A Fire Resistance Test  
Utilizing The General  
Principles Of  
BS 476: Part 20:1987 On  
five Air Transfer Grilles  
Mounted In A Non-  
Loadbearing Partition  
Wall Assembly

391348

**Mann McGowan  
Fabrications Ltd**  
4 Brook Trading Estate  
Deadbrook Lane  
Aldershot Hants  
GU12 4XB

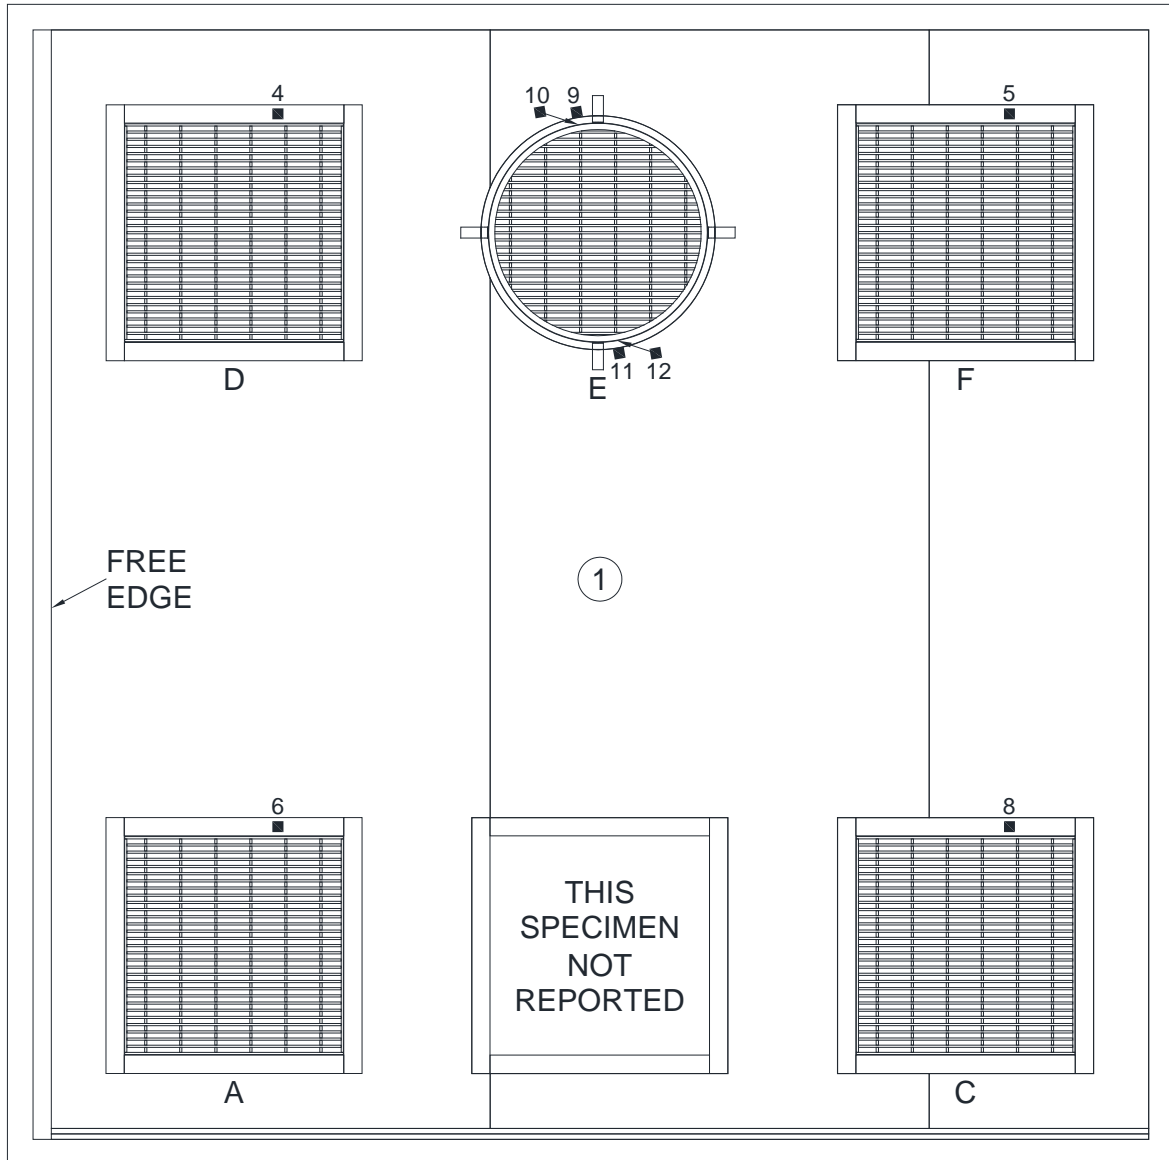
Figure 1- General Elevation of Test Construction

■ Positions of thermocouples

(Refer to Figures 1 to 8)

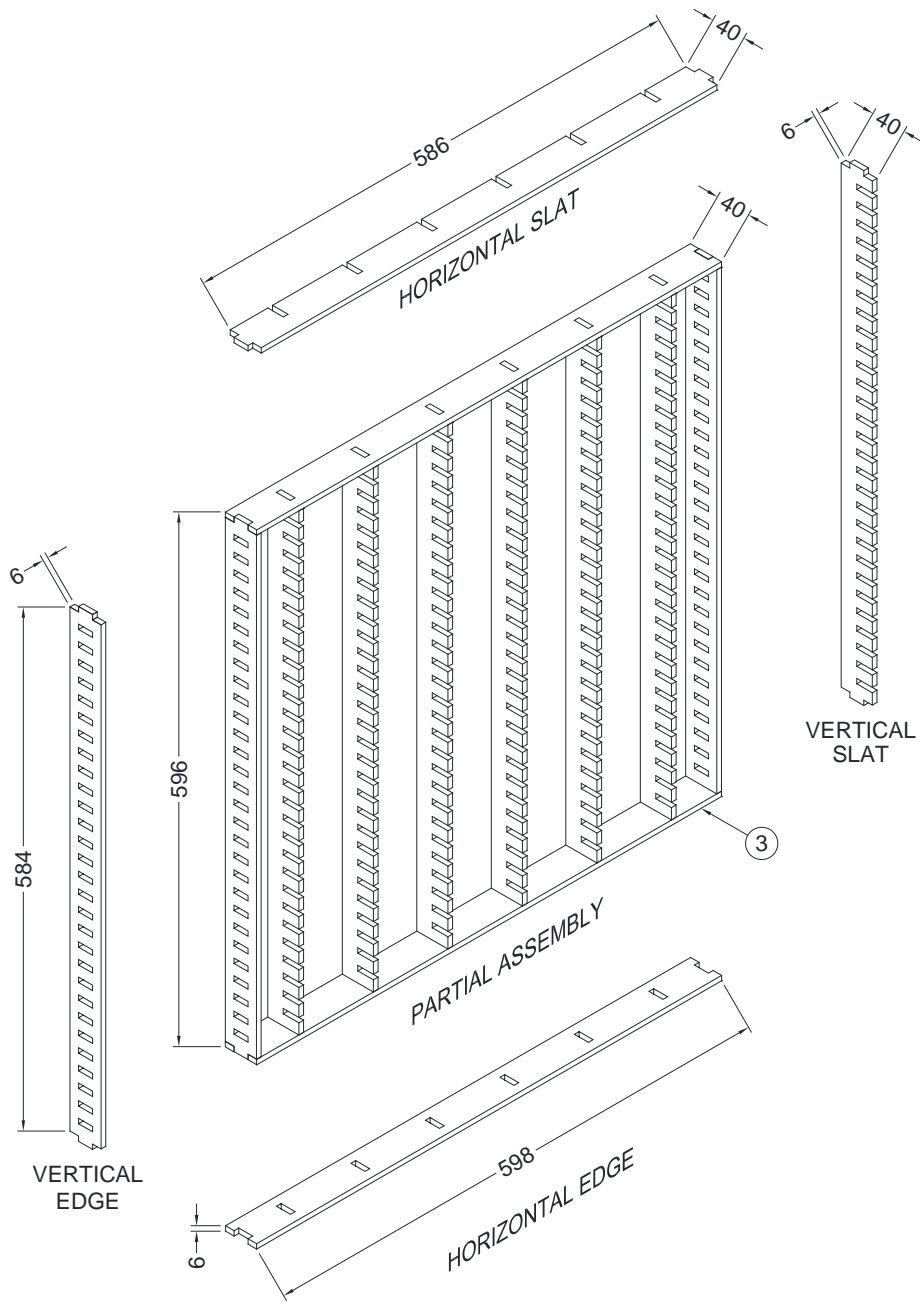
Figure 3 – Details of Grilles

EXPLODED VIEW OF  
SPECIMENS A & D

<u>Item</u>	<u>Description</u>
<b>3. Specimens A &amp; D</b>	
Manufacturer	: Mann M <sup>c</sup> Gowan
Reference	: Pyrogrille 100
Materials	
i. vertical slats	: Polyvinyl chloride, PVC, carrier with palusol intumescent and perforated galvanised mild steel strip inserts
ii. horizontal slats	: PVC, carrier with palusol intumescent strip insert
iii. perimeter edges	: PVC, carrier with palusol intumescent strip insert
Overall sizes

i. vertical slats	: 40 mm wide x 6 mm thick carrier with 37.5 mm wide x 2 mm thick palusol and 37.5 mm wide x 0.7 mm thick perforated galvanised mild steel strip inserts
ii. horizontal slats	: 40 mm wide x 6 mm thick carrier with 37.5 mm wide x 4mm thick palusol insert
iii. perimeter edges	: 40 mm wide x 6 mm thick carrier with 37.5 mm wide x 4mm thick palusol insert
iv. assembled grille	: 598 mm wide x 596 mm high
Assembly method	The vertical and horizontal slats contained notches along their lengths so that they interlocked with each other to form a grid. The ends of the slats were cut to form a tongue which located into corresponding slots in the perimeter edge sections. The perimeter of the grille was wrapped with duct tape. Please see Figure 3
Fixing method	: Screw fixed through vertical edges to the framework of the partition, item 1
Fixings

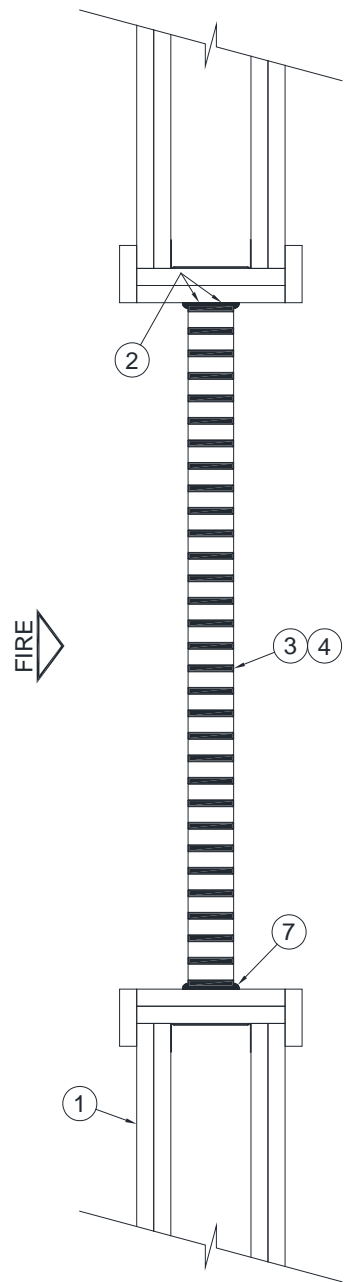
Figure 6 – Details of Grille

TYPICAL SECTION  
THROUGH SPECIMENS A, C & D

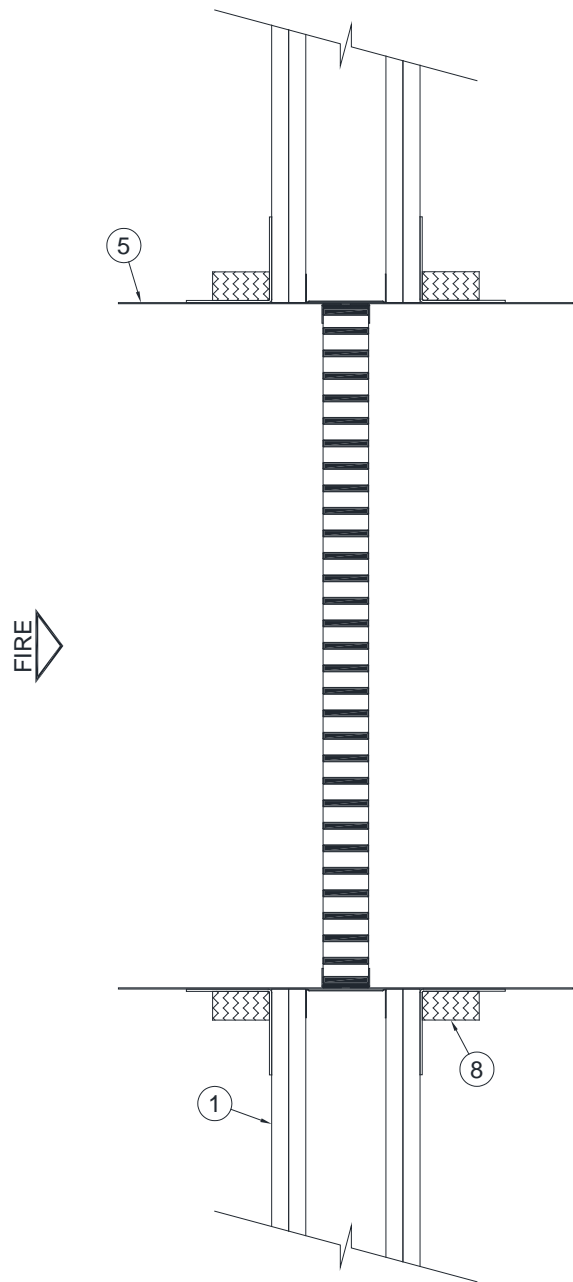
Figure 7 – Details of Grilles

TYPICAL SECTION  
THROUGH SPECIMEN E

i. casing	: Galvanised mild steel
ii. vertical slats	: Polyvinyl chloride, PVC, carrier with palusol intumescent and perforated galvanised mild steel strip inserts
iii. horizontal slats	: PVC, carrier with palusol intumescent strip insert
iv. perimeter seal	: Palusol sheet

v. perimeter retaining angles	: Spun and rolled galvanised mild steel
Overall sizes	
i. casing	: 600 mm diameter x 400 mm long x 1 mm thick
ii. vertical slats	: 40 mm wide x 6 mm thick carrier with 37.5 mm wide x 2 mm thick palusol and 37.5 mm wide x 0.7 mm thick perforated galvanised mild steel strip inserts
iii. horizontal slats	: 40 mm wide x 6 mm thick carrier with 37.5 mm wide x 4mm thick palusol insert
iv. perimeter seal	: 40 mm wide x 2 mm thick

v. perimeter retaining angles	: 17 mm x 17 mm x 1 mm thick
Assembly method	The vertical and horizontal slats contained notches along their lengths so that they interlocked with each other to form a grid. The ends of the slats were cut square. The perimeter of the grille was wrapped with a single layer of palusol sheet. Each side had a retaining angle fitted before the assembly was friction fitted into the casing
Fixing method	: Retained on both faces with a 75 mm x 75 mm x 30 mm wide x 2 mm thick mild steel angle brackets at each quadrant
Retaining bracket fixings to partition

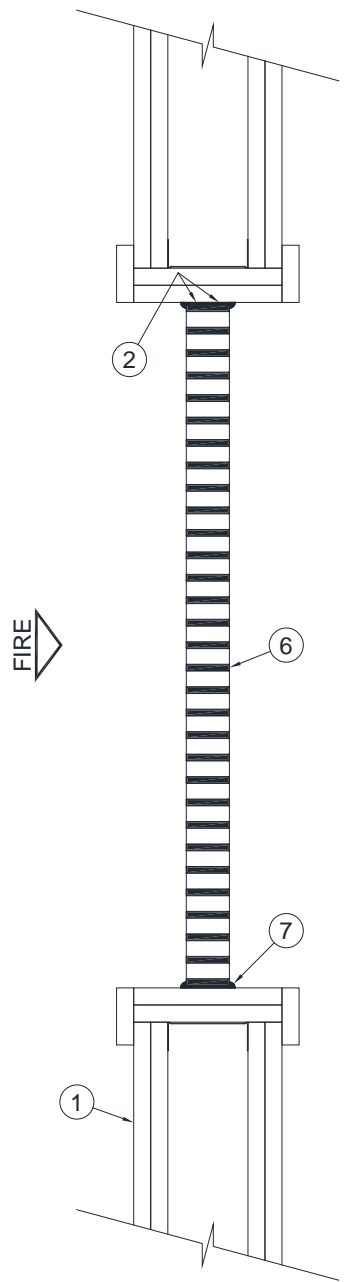
Figure 8 – Details of Grille

TYPICAL SECTION  
THROUGH SPECIMEN F

<u>Item</u>	<u>Description</u>
<b>6. Specimen F</b>	
Manufacturer	: Mann M <sup>c</sup> Gowan
Reference	: Pyrogrille 100
Materials	
i. vertical slats	: Polyvinyl chloride, PVC, carrier with palusol intumescent and perforated galvanised mild steel strip inserts
ii. horizontal slats	: PVC, carrier with palusol intumescent strip insert
iii. perimeter edges	: PVC, carrier with palusol intumescent strip insert
Overall sizes

i. vertical slats	: 38 mm wide x 6 mm thick carrier with 36 mm wide x 2 mm thick palusol and 36 mm wide x 0.7 mm thick perforated galvanised mild steel strip inserts
ii. horizontal slats	: 38 mm wide x 6 mm thick carrier with 36 mm wide x 4mm thick palusol insert
iii. perimeter edges	: 38 mm wide x 6 mm thick carrier with 36 mm wide x 4mm thick palusol insert
iv. assembled grille	: 598 mm wide x 596 mm high
Assembly method	The vertical and horizontal slats contained notches along their lengths so that they interlocked with each other to form a grid. The ends of the slats were cut to form a tongue which located into corresponding slots in the perimeter edge sections. The perimeter of the grille was wrapped with duct tape. Please see Figure 5
Fixing method	: Screw fixed through vertical edges to the framework of the partition, item 1
Fixings

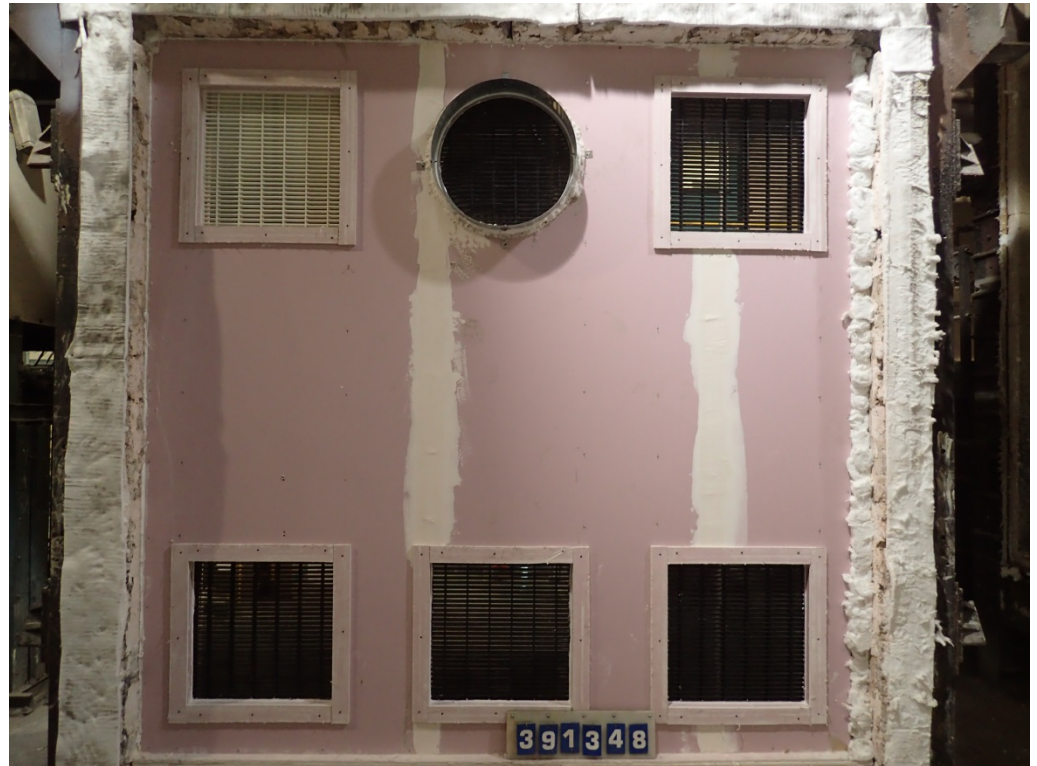
The exposed face of the test constructions prior to testing

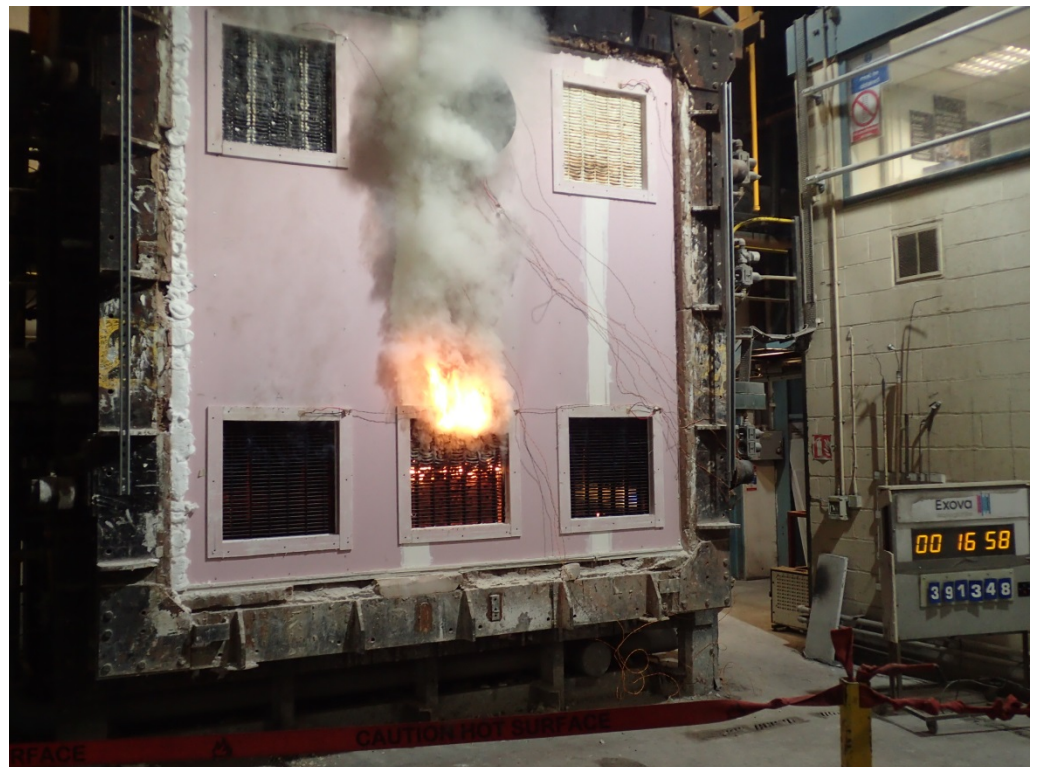
The unexposed face of the test construction after a test duration of 16 minutes

Time		All observations are from the unexposed face unless noted otherwise.
mins	secs	The ambient air temperature in the vicinity of the test construction was 15°C at the start of the test with a maximum variation of $\pm 1^\circ\text{C}$ during the test.
00	00	<b>The test commences.</b>
00	30	Specimen F begins to react.
01	00	Specimens E and D begin to react.
02	00	Specimens D, E and F have fully closed. Slight smoke release from specimens D and E.
03	50	Slight smoke release from specimen F.
09	05	The top of grilles specimens F, B and C begins to react.
10	00	When viewed from the exposed face, the plasterboard begins to glow a dull orange in colour.
19	00	Specimens A and C have fully closed.
30	00	Specimens A, C, D, E and F satisfy the test criteria.
37	00	Glowing is evident through the specimens D and E.
45	00	The joints in the exposed layer of plasterboard begin to shrink.
50	00	No further significant changes are evident at this time.

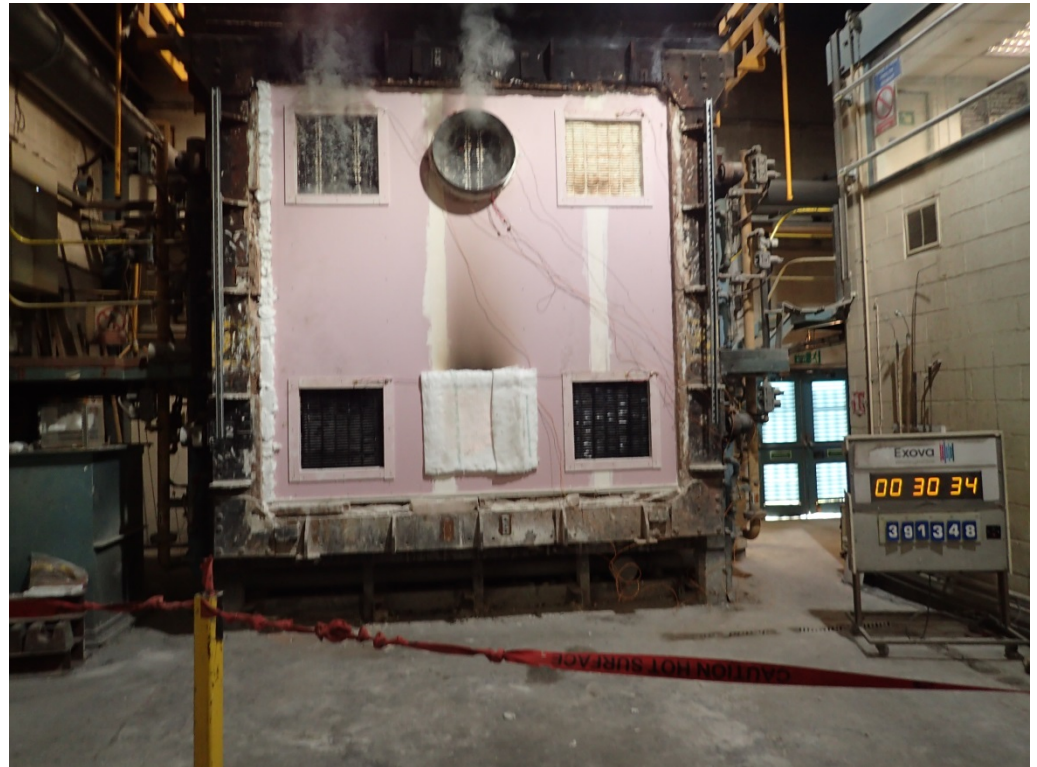
The unexposed face of the test constructions after a test duration of 30 minutes

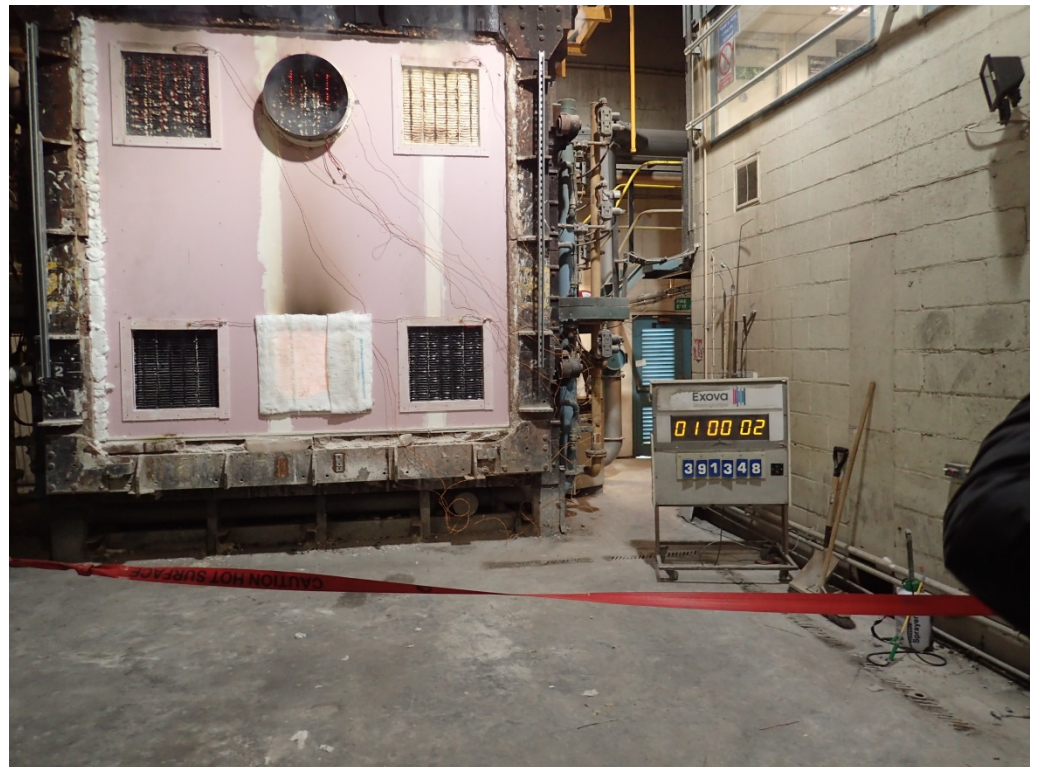
The unexposed face of the test constructions after a test duration of 60 minutes

60	00	Specimens A, C, D, E and F continue to satisfy the test criteria.
70	00	Slight glowing is evident in specimens A, C and F.
90	00	Specimens A, C, D, E and F continue to satisfy the test criteria.
120	00	Specimens A, C, D, E and F continue to satisfy the test criteria. <b>Test discontinued.</b>

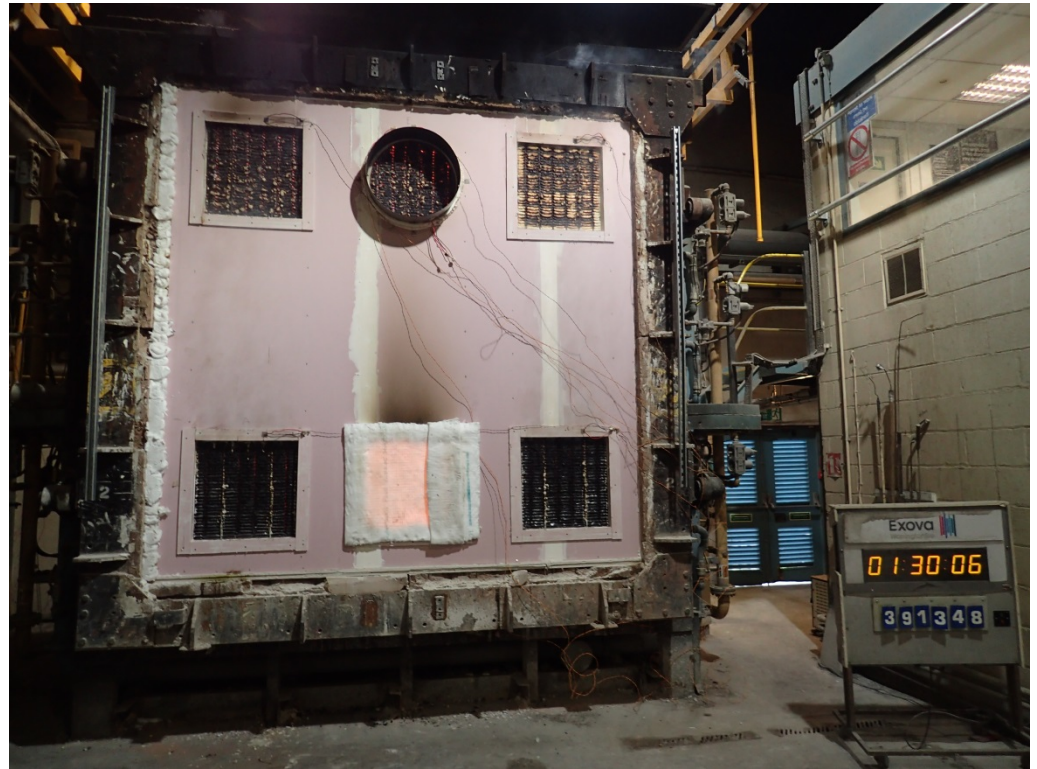
The unexposed face of the test constructions after a test duration of 90 minutes

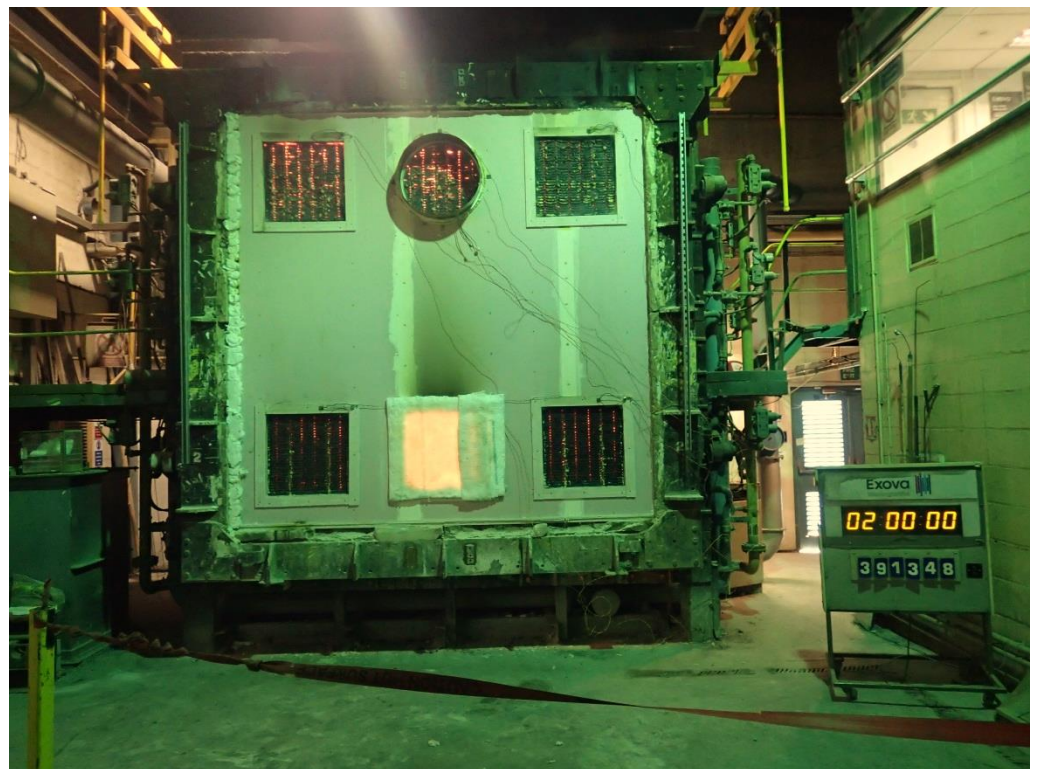
The unexposed face of the test constructions after a test duration of 120 minutes

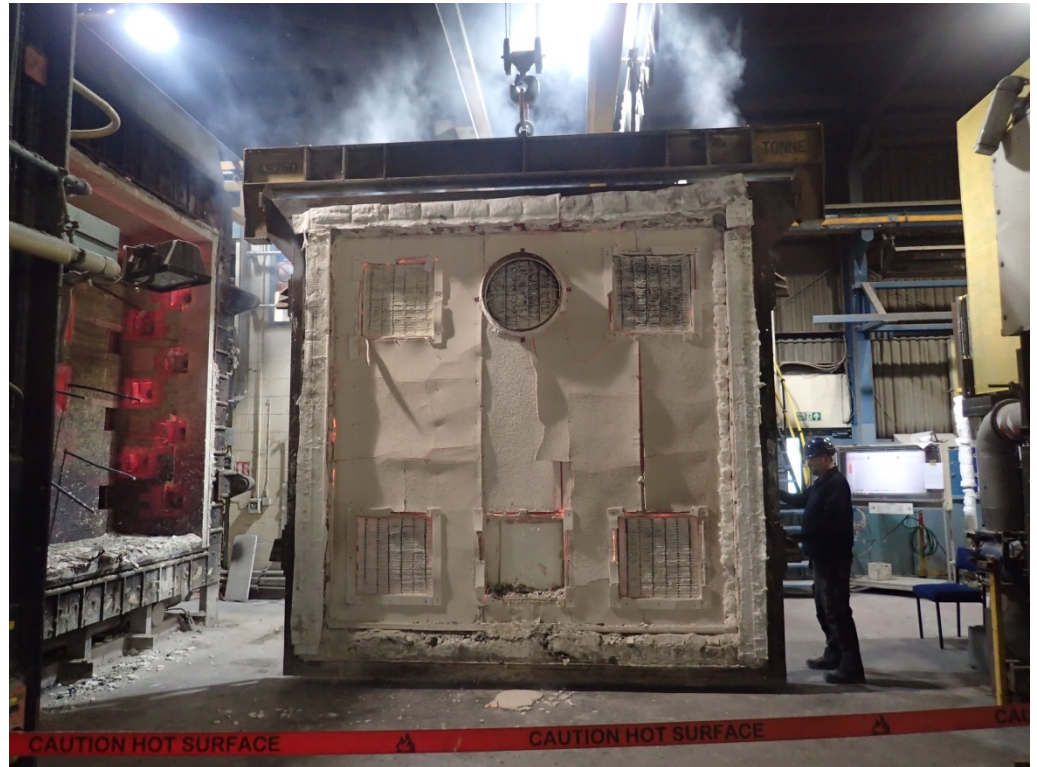
The exposed face of the test constructions immediately after the test

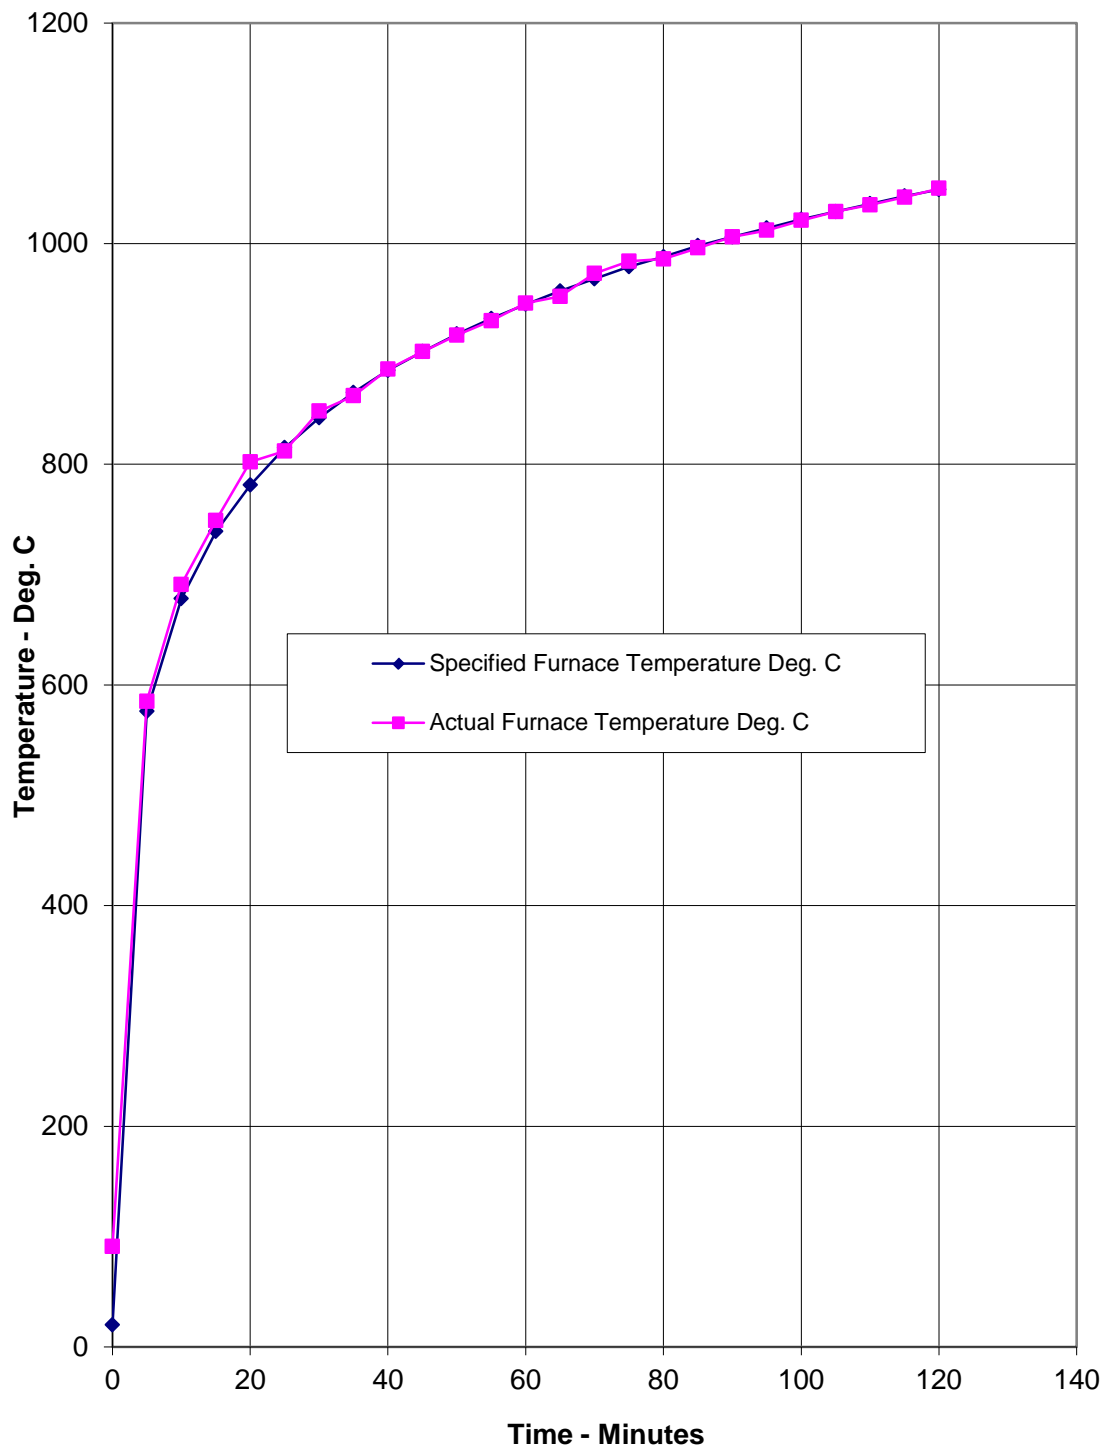
Graph showing mean furnace temperature, together with the temperature/time relationship specified in the Standard

Time Mins	Specified Furnace Temperature Deg. C	Actual Furnace Temperature Deg. C
0	20	91
5	576	585
10	678	691
15	739	749
20	781	802
25	815	812
30	842	848
35	865	862
40	885	886
45	902	902
50	918	917
55	932	930
60	945	946
65	957	952
70	968	973
75	979	984
80	988	986
85	998	996
90	1006	1006
95	1014	1012
100	1022	1021
105	1029	1029
110	1036	1035
115	1043	1042
120	1049	1050

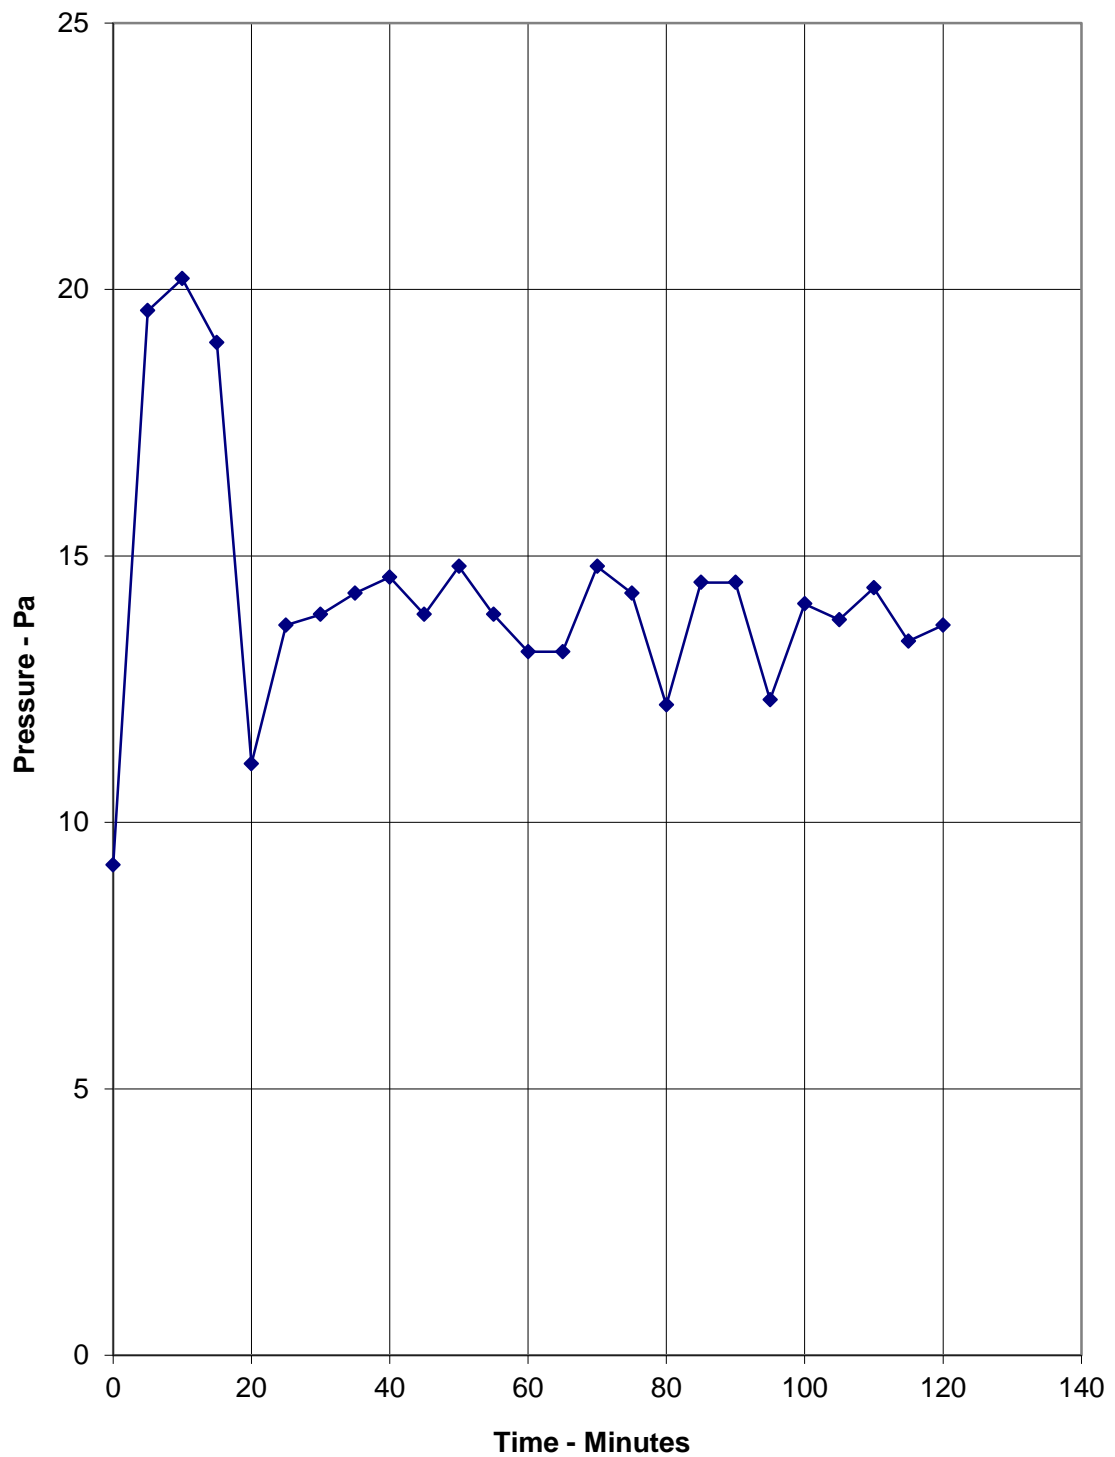
Graph showing the recorded furnace pressure recorded 300 mm below the head of the assembly

<b>Integrity criteria</b>	Cotton pads and gap gauges were available to evaluate the integrity of the specimens.
<b>Furnace Pressure</b>	After the first five minutes of testing and for the remainder of the test, the furnace pressure was controlled so that it complied with the requirements of BS 476: Part 20: 1987, Clause 3.2.2. The calculated pressure differential relative to the laboratory atmosphere at mid height of Specimens D to F was 0 ( $\pm 2$ ) Pa, and for Specimens A to C 11 ( $\pm 2$ ) Pa.
