# Test Report

The fire resistance performance of two fully insulated, timber, single acting single door assemblies when tested in accordance with BS EN 1634-1:2014+A1:2018

Project ID 20221031-005714

Prepared For RAM Extrusion  
Unit 203  
Stonebridge Cross Business Park  
Pionton Way  
Droitwich Spa  
WR9 0LW

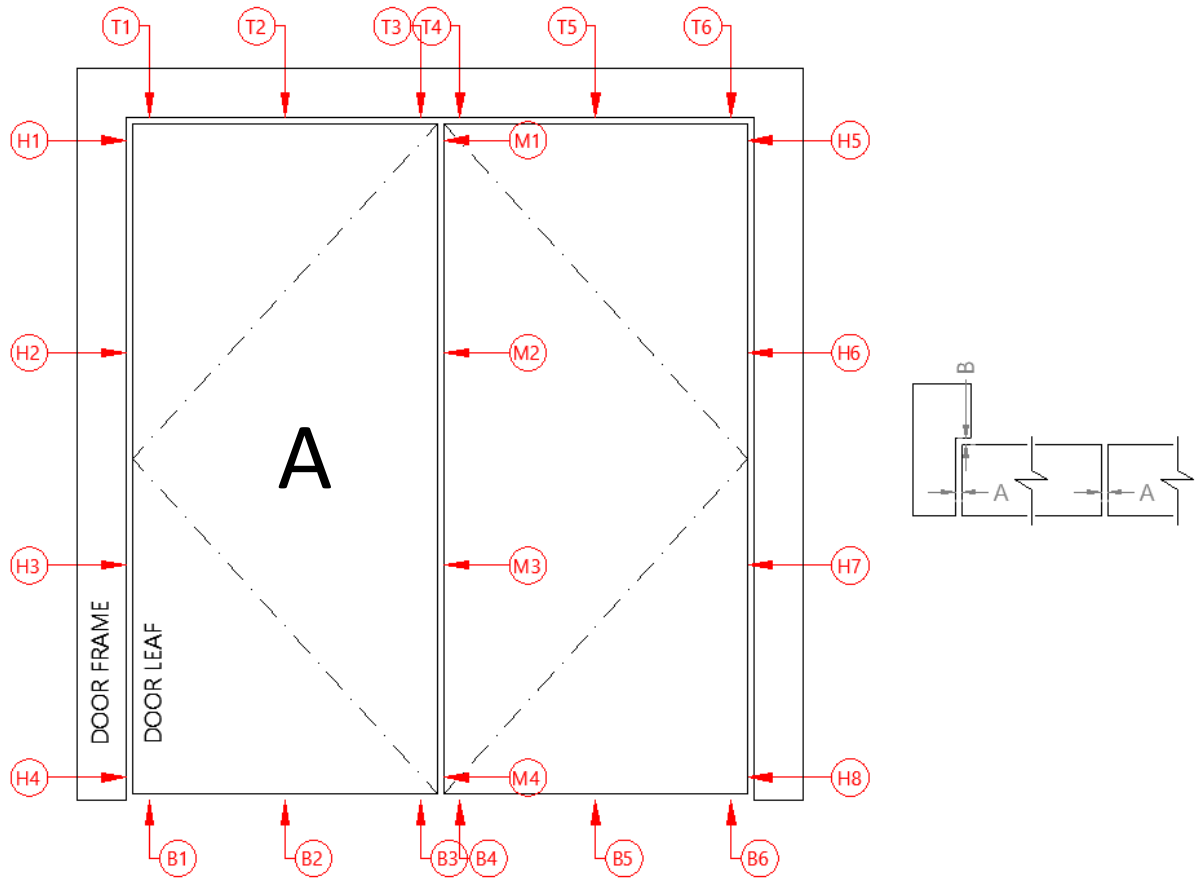
A	B		A	B		A	B	
H1	1.2	0.1	X	M1	1.6	X	H5	1.3	
H2	2.1	0.1		M2	1.6		H6	2.4	
H3	1.3	0.1		M3	1.5		H7	1.1	
H4	1.8	0.1		M4	1.2		H8	1.7	
<b>Mean</b>	<b>1.6</b>	X	<b>Mean</b>	<b>1.5</b>	X	<b>Mean</b>	<b>1.6</b>	X	
<b>Max</b>	<b>2.1</b>		<b>Max</b>	<b>1.6</b>		<b>Max</b>	<b>2.4</b>		
<b>Min</b>	<b>1.2</b>		<b>Min</b>	<b>1.2</b>		<b>Min</b>	<b>1.1</b>		
	A	B		A	B		A	B	
T1	2.3	0.1	T4	1.5	0.2	B1	4.7	B4	4.2
T2	1.9	0.1	T5	1.4	0.1	B2	3.5	B5	4.9
T3	1.6	0.1	T6	1.4	0.1	B3	3.5	B6	5.9
<b>Mean</b>	<b>1.9</b>	X	<b>Mean</b>	<b>1.4</b>	X	<b>Mean</b>	<b>3.9</b>	<b>Mean</b>	<b>5.0</b>
<b>Max</b>	<b>2.3</b>		<b>Max</b>	<b>1.5</b>		<b>Max</b>	<b>4.7</b>	<b>Max</b>	<b>5.9</b>
<b>Min</b>	<b>1.6</b>		<b>Min</b>	<b>1.4</b>		<b>Min</b>	<b>3.5</b>	<b>Min</b>	<b>4.2</b>

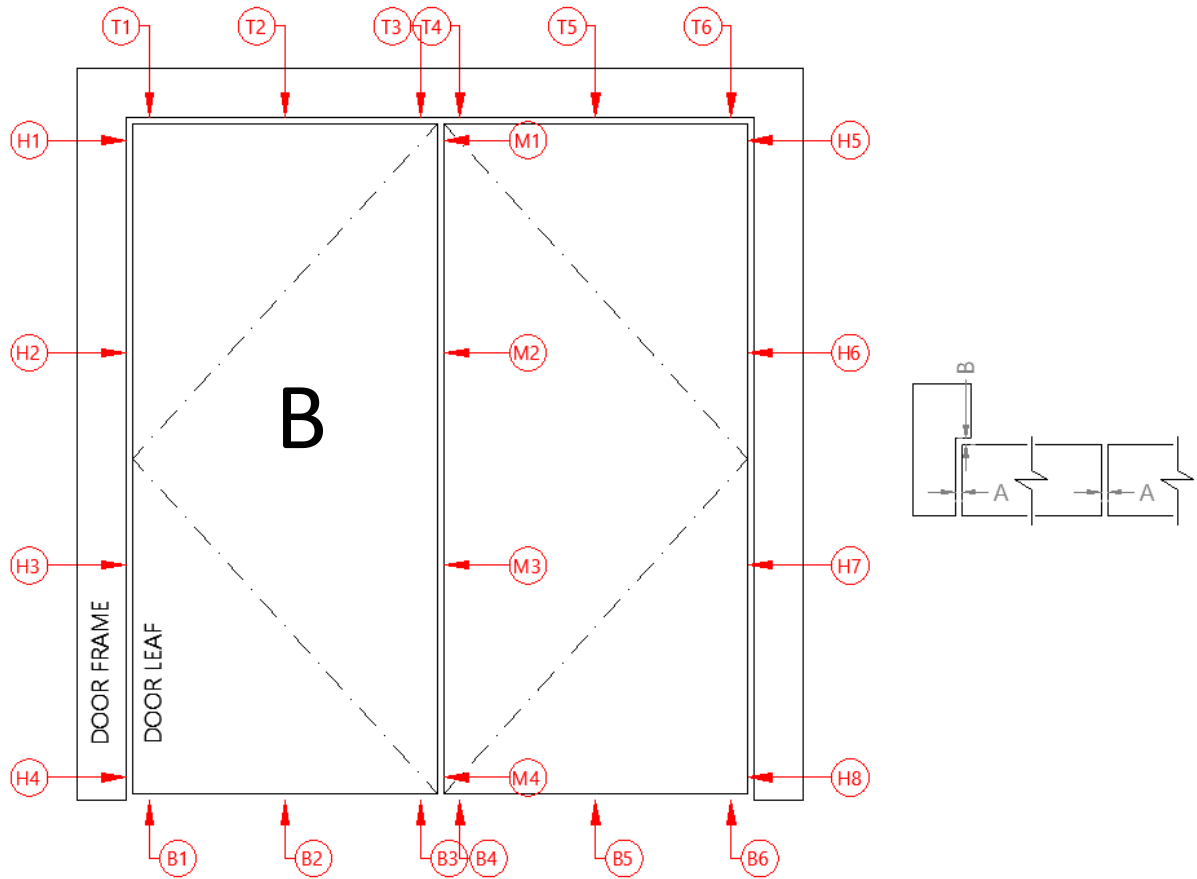
A	B		A	B		A	B	
H1	1.7	0.1	X	M1	2.5	X	H5	2.2	0.1
H2	1.7	0.1		M2	2.0		H6	1.5	0.2
H3	1.1	0.5		M3	1.7		H7	1.2	0.5
H4	1.3	0.8		M4	1.8		H8	1.5	0.7
<b>Mean</b>	<b>1.4</b>	X	<b>Mean</b>	<b>2.0</b>	X	<b>Mean</b>	<b>1.6</b>	X	
<b>Max</b>	<b>1.7</b>		<b>Max</b>	<b>2.5</b>		<b>Max</b>	<b>2.2</b>		
<b>Min</b>	<b>1.1</b>		<b>Min</b>	<b>1.7</b>		<b>Min</b>	<b>1.2</b>		
	A	B		A	B		A	B	
T1	1.2	1.2	T4	2.2	0.4	B1	3.6	B4	2.1
T2	1.5	0.7	T5	2.4	0.5	B2	2.7	B5	1.0
T3	1.8	0.2	T6	1.9	0.4	B3	2.9	B6	2.8
<b>Mean</b>	<b>1.5</b>	X	<b>Mean</b>	<b>2.2</b>	X	<b>Mean</b>	<b>3.1</b>	<b>Mean</b>	<b>2.0</b>
<b>Max</b>	<b>1.8</b>		<b>Max</b>	<b>2.4</b>		<b>Max</b>	<b>3.6</b>	<b>Max</b>	<b>2.8</b>
<b>Min</b>	<b>1.2</b>		<b>Min</b>	<b>1.9</b>		<b>Min</b>	<b>2.7</b>	<b>Min</b>	<b>1.0</b>

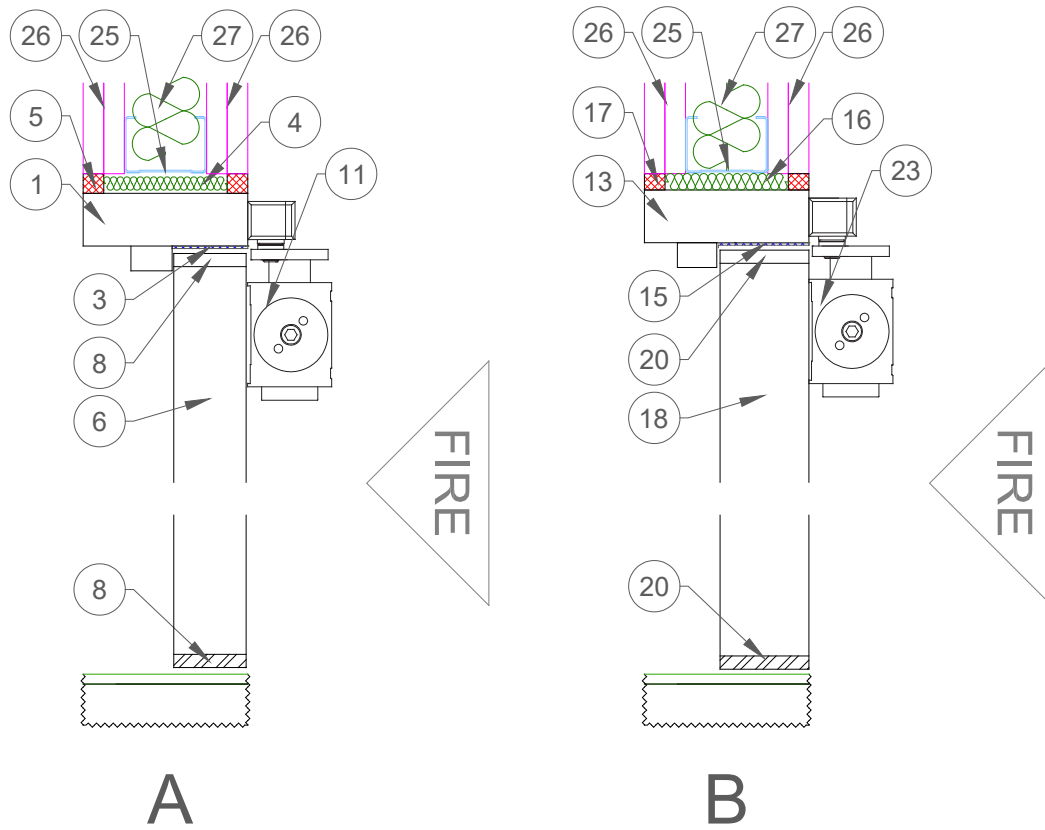
Figure 2 - Typical vertical section through the specimens

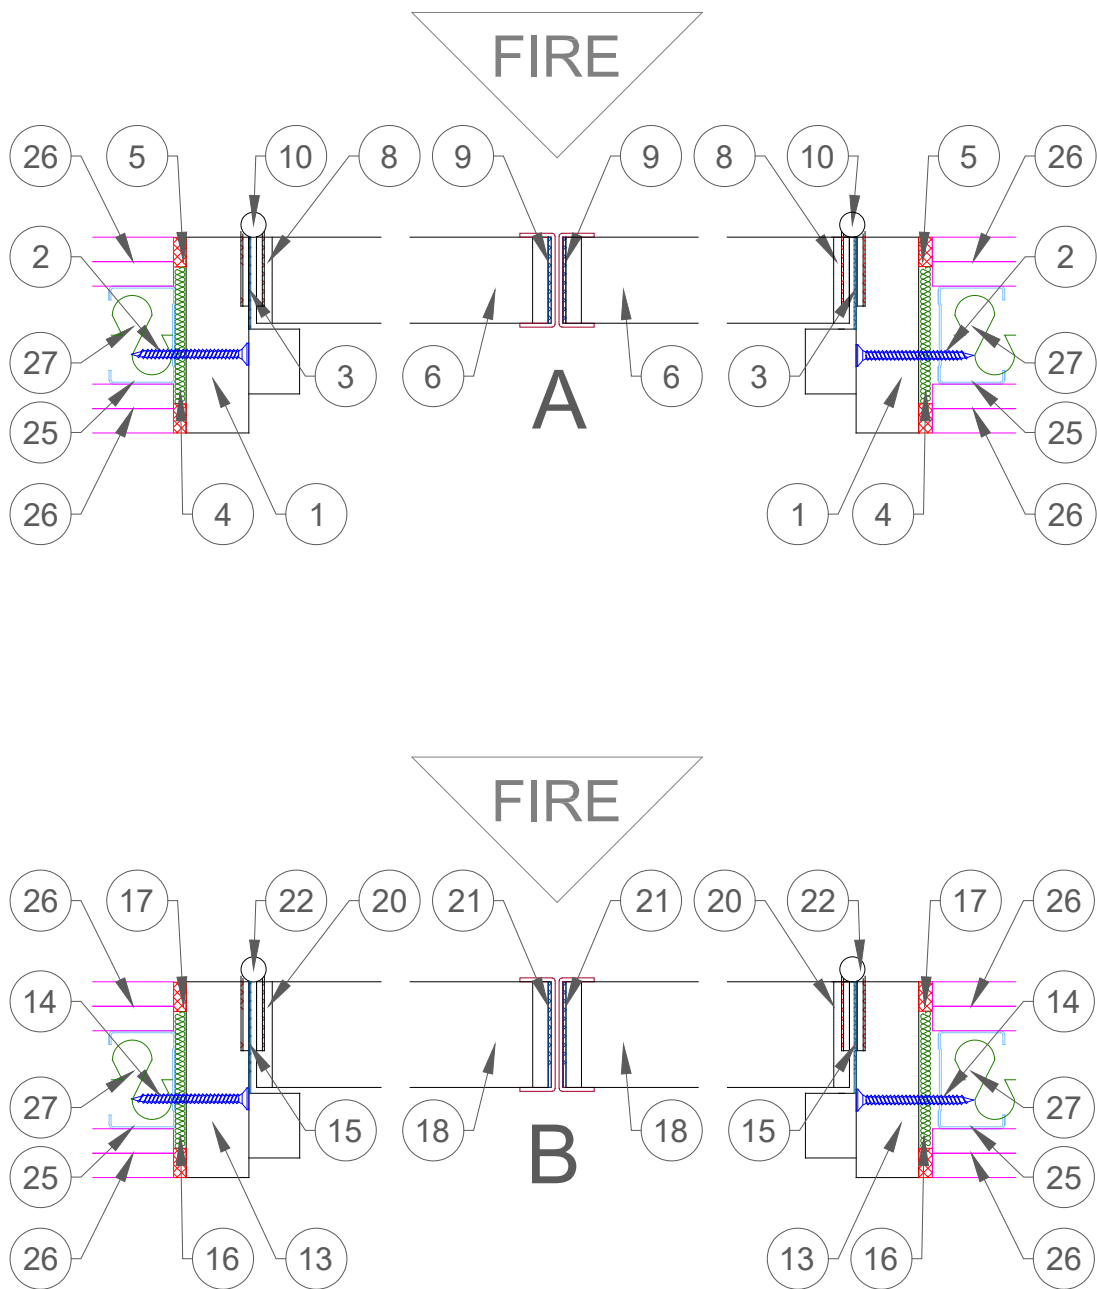
Figure 3 - Typical horizontal section through the specimens

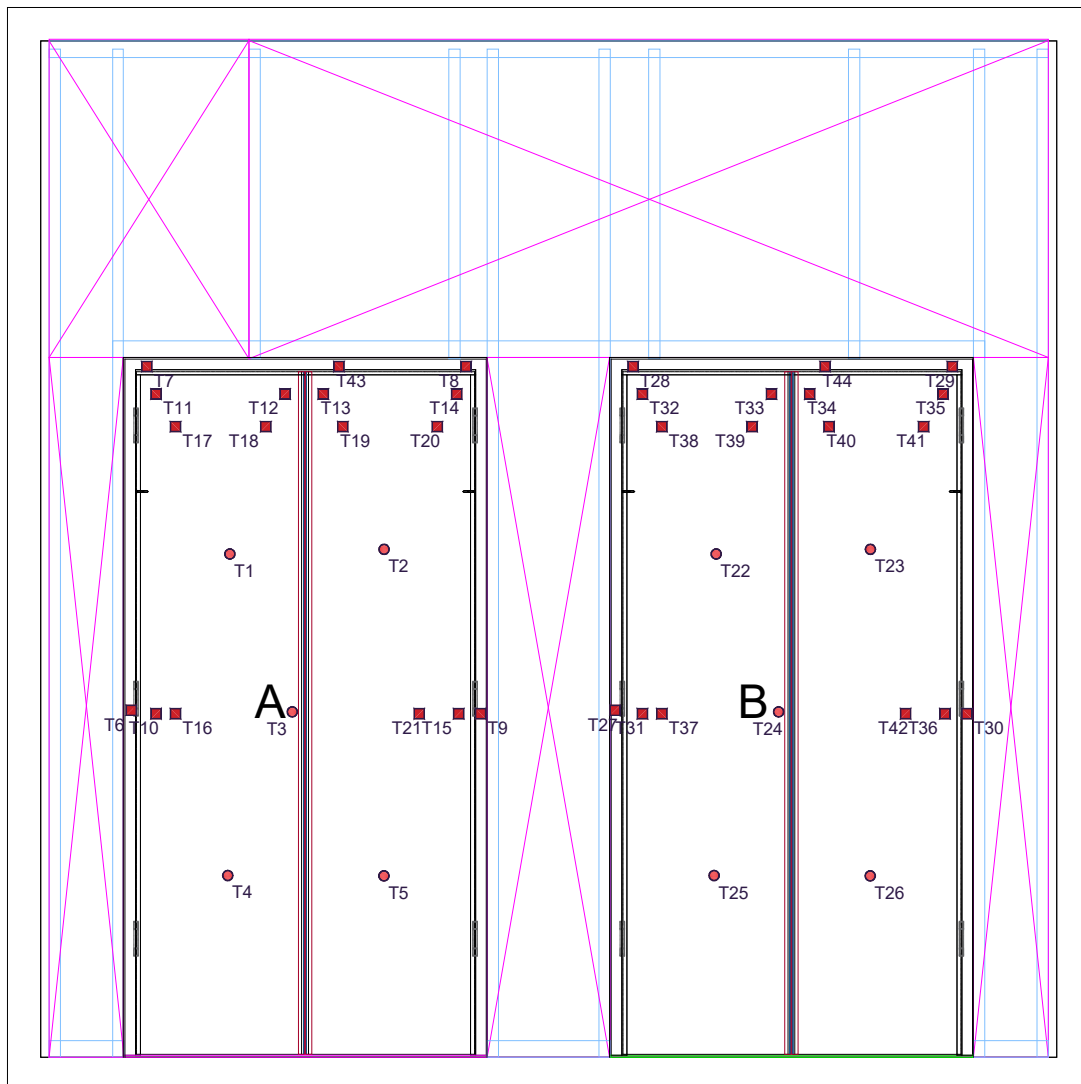
Figure 4 - Layout of instrumentation viewed from the unexposed surface of the test construction

Disc thermocouples were affixed to the unexposed surface of the specimens in accordance with BS EN 1634-1:2014+A1:2018 § 9.1.2 to measure and monitor the maximum and the mean temperature rise of the unexposed surface of the specimens for the duration of the test. A summary of the measurements is presented in Figure 28 and Figure 29 and the locations of these thermocouples is illustrated in Figure 4.

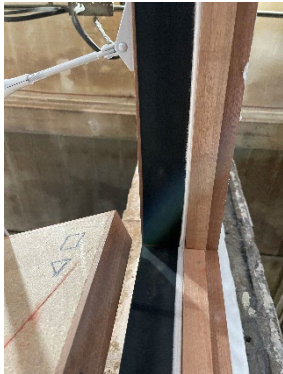
Figure 5 - Item 1, 3, 13 & 15

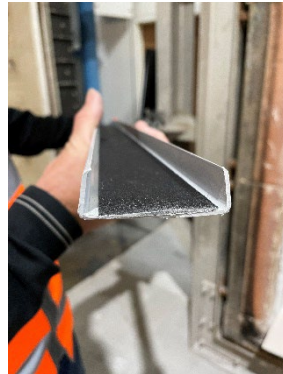
Figure 6 - Item 9 & 21

9. Door Edge Shield	
Manufacturer	RAM Extrusion
Reference	44 mm FD 30 Door Edge Shield
Material	Rigid PVC with flexible bumper and High Expansion Graphite Intumescent to back.
Intumescent ref	44 mm wide x 1.5 mm thick – Pyrosist
Overall section size	47 mm wide x 19 mm upstand x 1.5 mm thick
Location	1 no attached to each leaf.
Application Method	Pin fixed at 3 locations – 45 mm down from top, 35 mm up from bottom and one 1000 mm up from bottom.

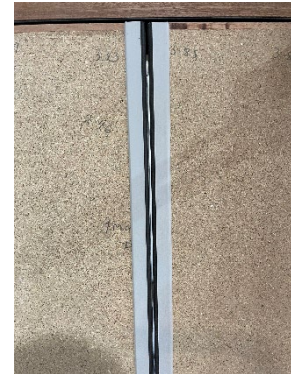
Figure 7 - Item 9 & 21

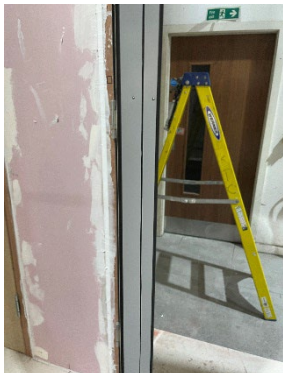
Figure 8 – Item 21

21. Door Edge Shield	
Manufacturer	RAM Extrusion
Reference	54 mm FD 60 Door Edge Shield
Material	Rigid PVC with flexible bumper and High Expansion Graphite Intumescent to back.
Intumescent ref	54 mm wide x 1.5 mm thick – Pyrosist
Overall section size	57 mm wide x 19 mm upstand x 1.5 mm thick
Location	1 no attached to each leaf.

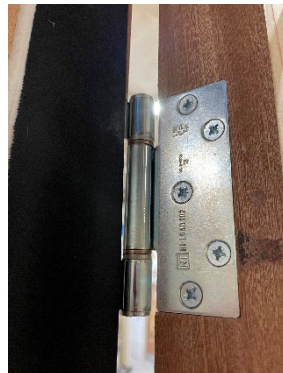
Figure 9 - Item 3, 10, 15, 22

10. Hinges	
Supplier	Royde and Tucker Manufacturing
Reference	H102
Quantity	3 no.
Primary material	Steel
Type	Ball Butt Bearing
a. Size	
i. Knuckle	Ø 14 mm x 104 mm high
ii. Blades	100 mm high x 35 mm wide x 3 mm thick

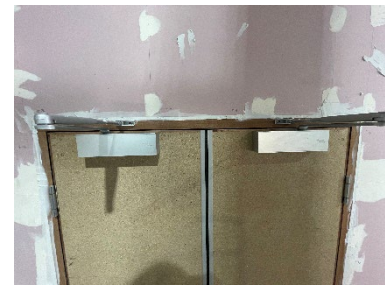
Figure 10 - Item 11 & 23

11. Door Closer	
Manufacturer	DORMA
Reference	TS72
a. Material	
i. Body	Mild Steel
ii. Closer arm	Stainless Steel
iii. Cover	Plastic
Configuration	Cam. Action Slide Arm
b. Overall size	
i. Slide arm	275 mm wide x 22 mm thick x 21 mm deep
ii. Body	57 mm high x 230 mm wide x 40 mm deep
iii. Cover	68 mm high x 232 mm wide x 455 mm deep
Fixing method	Screwed with 4 no Ø 5 mm x 50 mm stainless steel screws
12. Door Pin ID Tag	
Manufacturer	Door Data Systems
Reference	Data ID Tag
Material	Computer chip with dual plastic coating
Overall size	Ø 6 mm x 37.5 mm long
Location	Hinge edge – 865 from top of door and 19 in from hinge face of Each door.
Fixing method	Friction fitted into door edge.

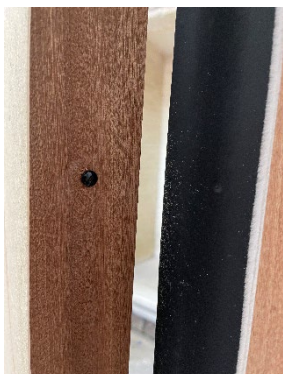
Figure 11- Item 12 & 24

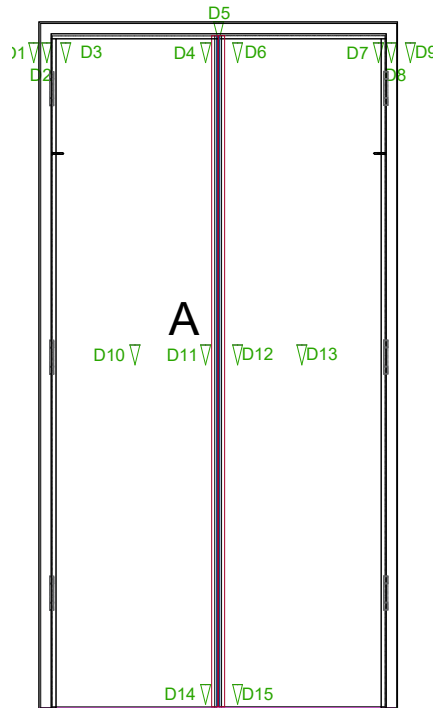
All measurements are in millimeters (mm) unless stated otherwise. Positive values indicate movement towards the heating conditions.

Time (mins)	D1	D2	D3	D4	D5	D6	D7	D8	D9	D10	D11	D12	D13	D14	D15
0	0	0	0	0	0	0	0	0	0	0	0	0	0	0	0
10	2	4	3	6	7	9	8	9	8	4	4	5	5	3	3
20	2	5	3	3	4	6	5	5	5	0	1	0	0	6	6
25	2	4	4	3	5	7	5	4	5	-2	-2	-1	-1	7	7
30	2	6	3	3	6	9	7	9	6	-2	-3	-2	-2	8	8
40	3	7	5	5	6	9	10	13	10	-7	-8	-6	-6	8	8

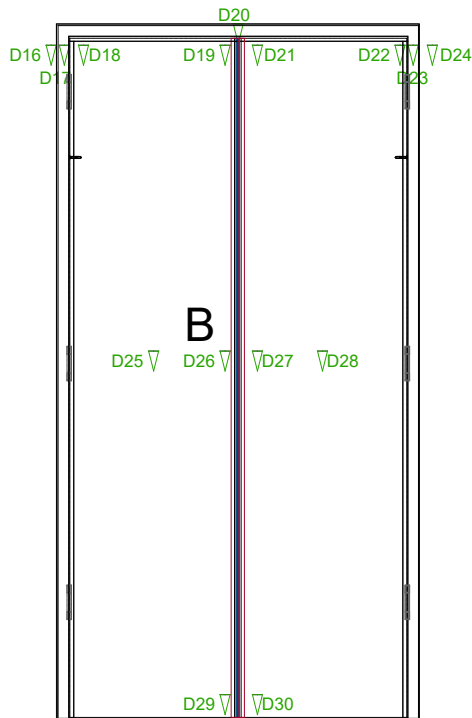
Time (mins)	D16	D17	D18	D19	D20	D21	D22	D23	D24	D25	D26	D27	D28	D29	D30
0	0	0	0	0	0	0	0	0	0	0	0	0	0	0	0
10	7	6	6	7	7	7	4	7	-3	2	0	1	2	0	3
20	3	5	4	5	5	9	-5	7	0	-1	-3	0	3	2	5
25	4	7	6	3	3	8	6	6	6	-1	-2	0	2	2	7
30	8	8	9	11	7	9	9	9	7	2	0	3	5	4	9
40	12	16	15	16	9	17	14	12	14	0	3	6	7	5	11
50	34	38	35	41	35	38	39	35	26	16	20	17	21	4	10
55	43	48	47	49	45	47	52	52	53	19	18	23	29	4	11
60	51	56	55	59	53	56	62	61	60	18	20	26	31	5	12

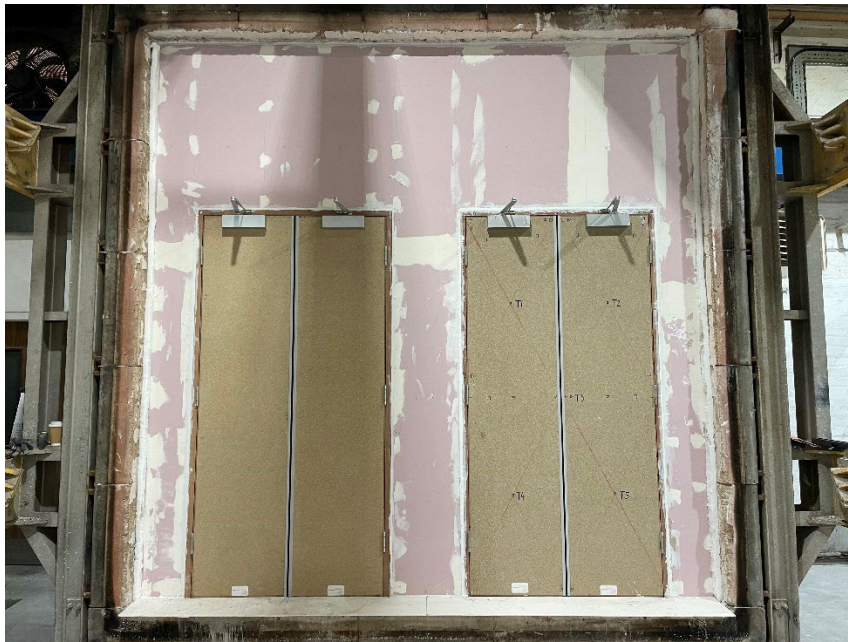
Figure 12 – The exposed surface of the test construction prior to commencement of the test

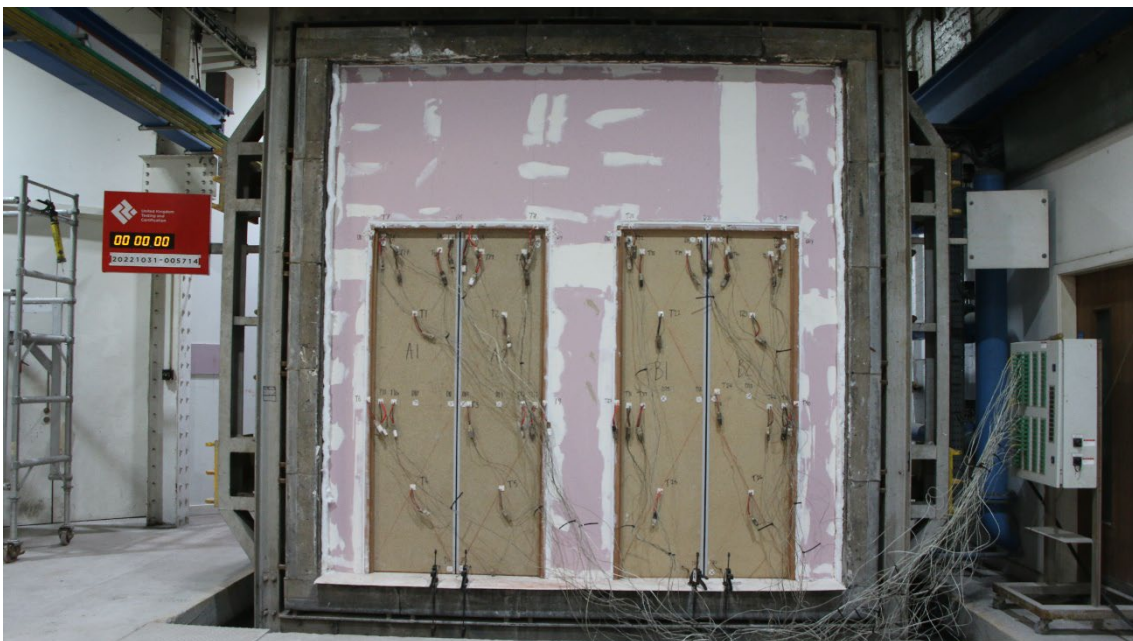
Figure 13 - The unexposed surface of the test construction prior to the commencement of the test

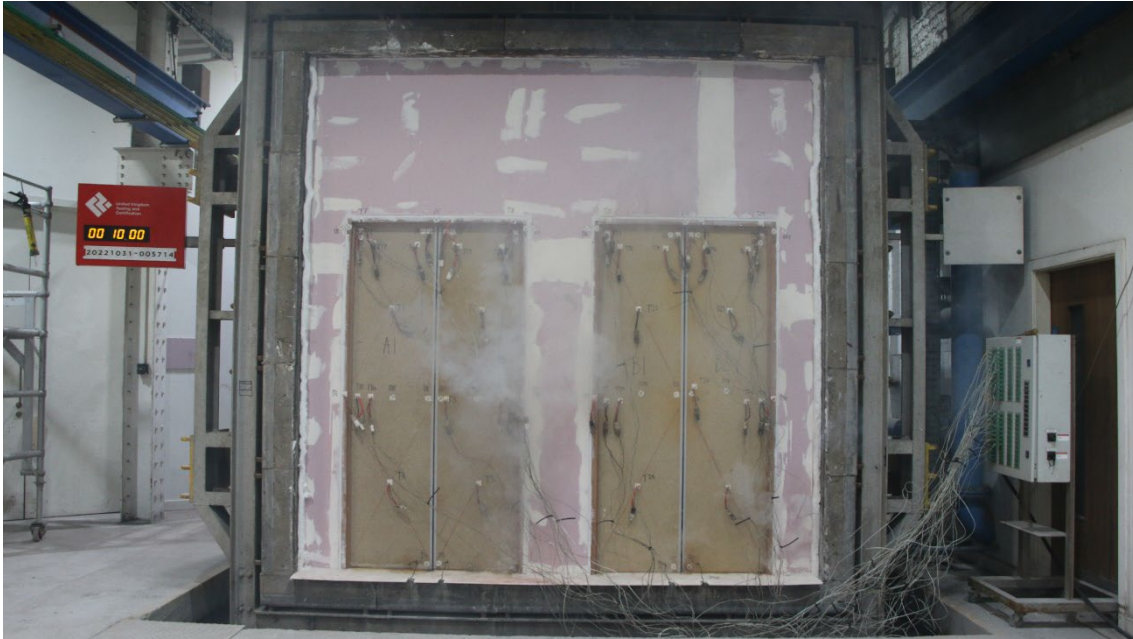
Figure 14 - The unexposed surface of the test construction after a test duration of 10 minutes

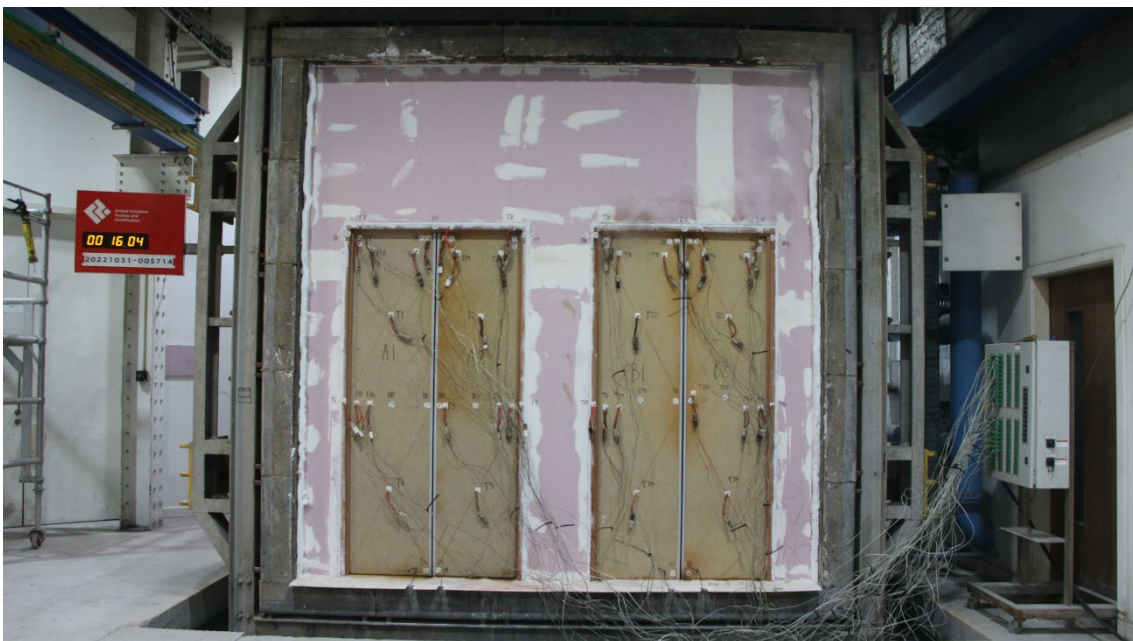
Figure 15 - The unexposed surface of the test construction after a test duration of 16 minutes

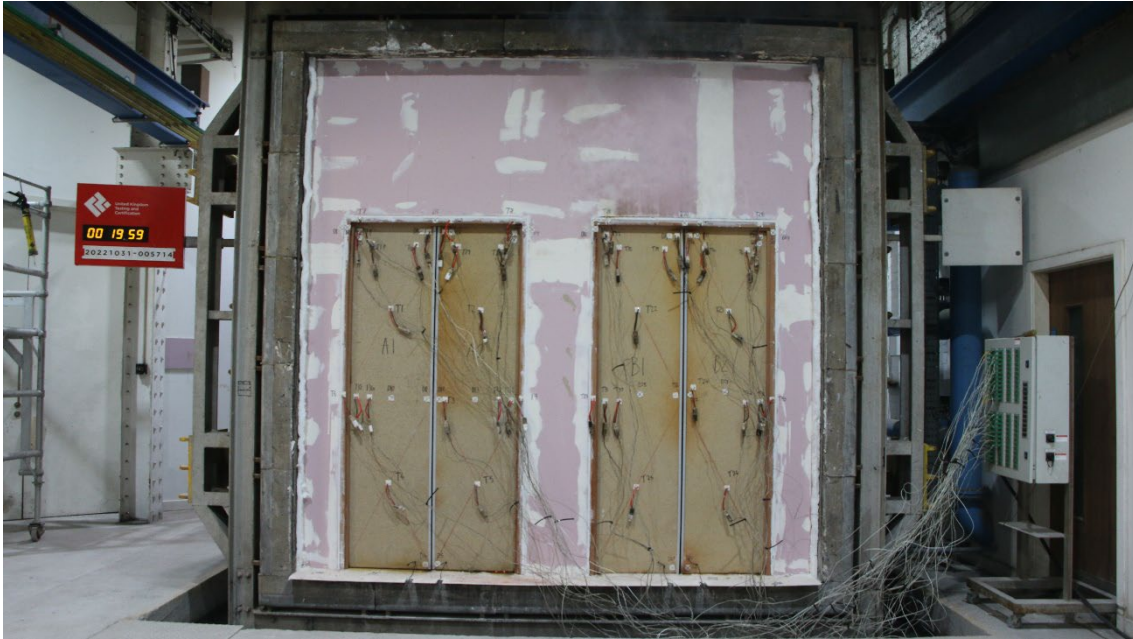
Figure 16 - The unexposed surface of the test construction after a test duration of 19 minutes

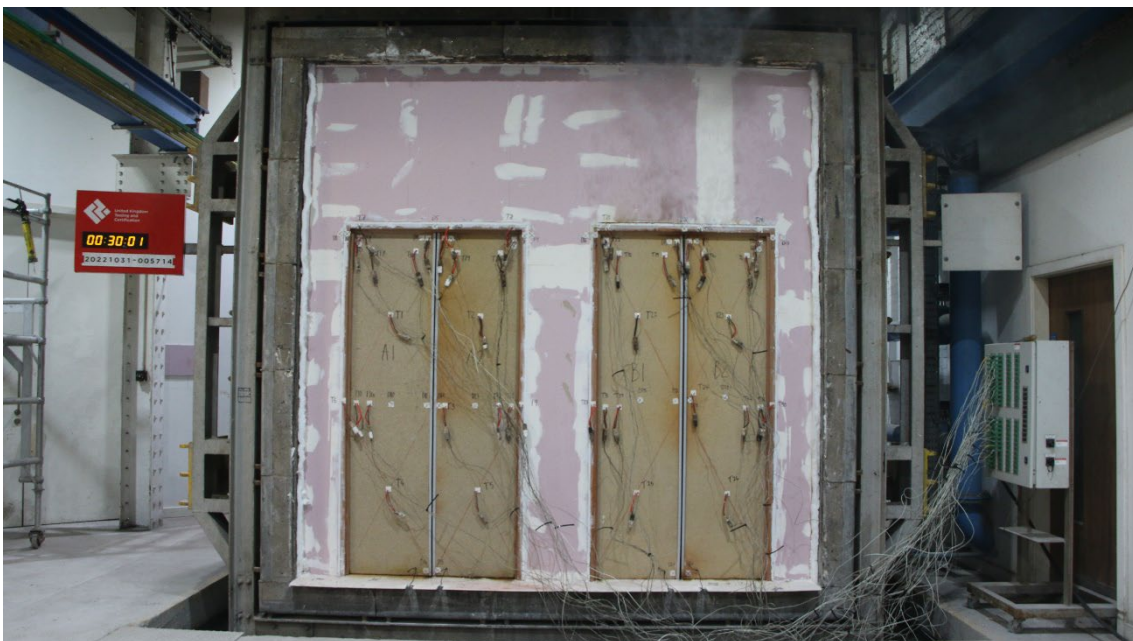
Figure 17 - The unexposed surface of the test construction after a test duration of 30 minutes

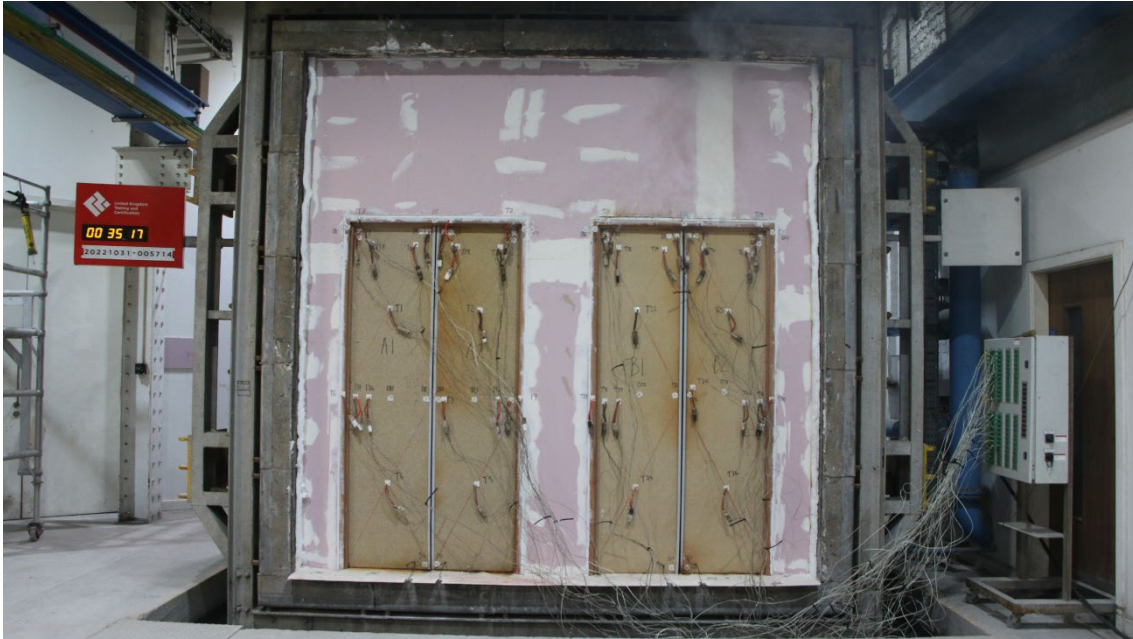
Figure 18 - The unexposed surface of the test construction after a test duration of 35 minutes

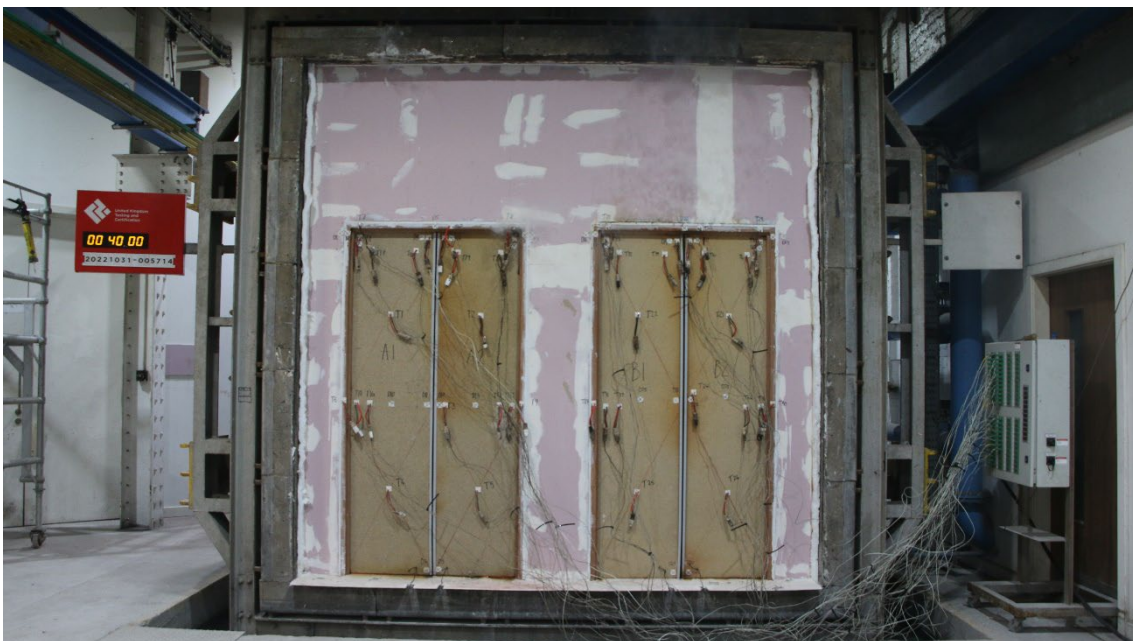
Figure 19 - The unexposed surface of the test construction after a test duration of 40 minutes

<b>A</b>	<b>00</b>	<b>42</b>	<b>00</b>		<b>X</b>	<b>Doorset Blanked over. To allow continuation of test for specimen B.</b>
B	00	48	01		X	Bottom of right-hand door has eroded and melted aluminum rests underneath.

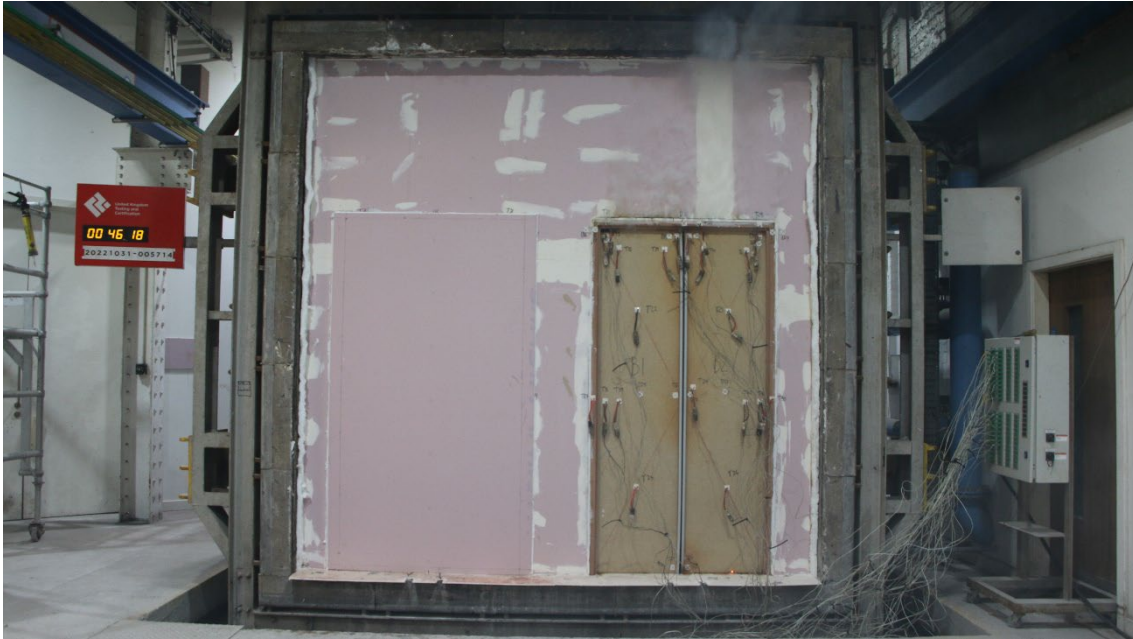
Figure 20 - The unexposed surface of the test construction after a test duration of 46 minutes

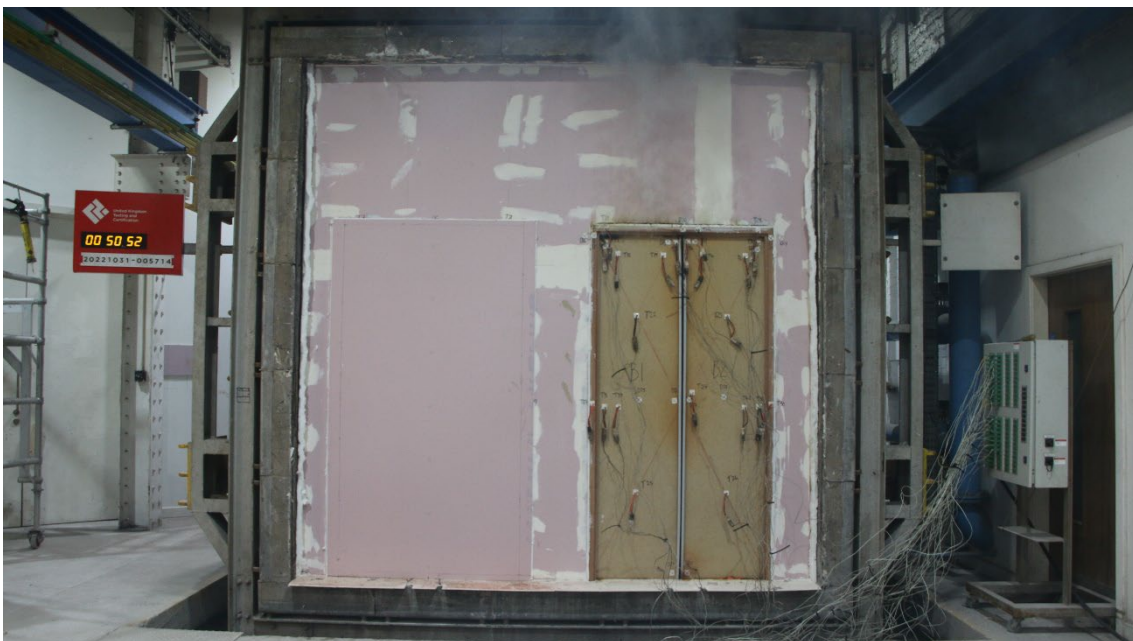
Figure 21 - The unexposed surface of the test construction after a test duration of 50 minutes

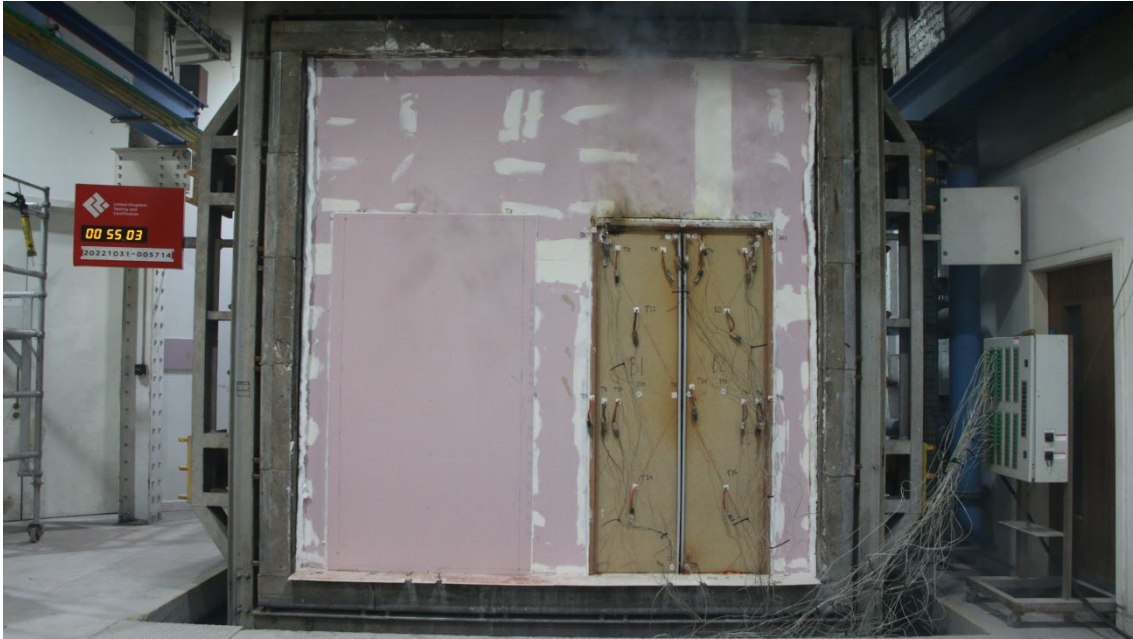
Figure 22 - The unexposed surface of the test construction after a test duration of 55 minutes

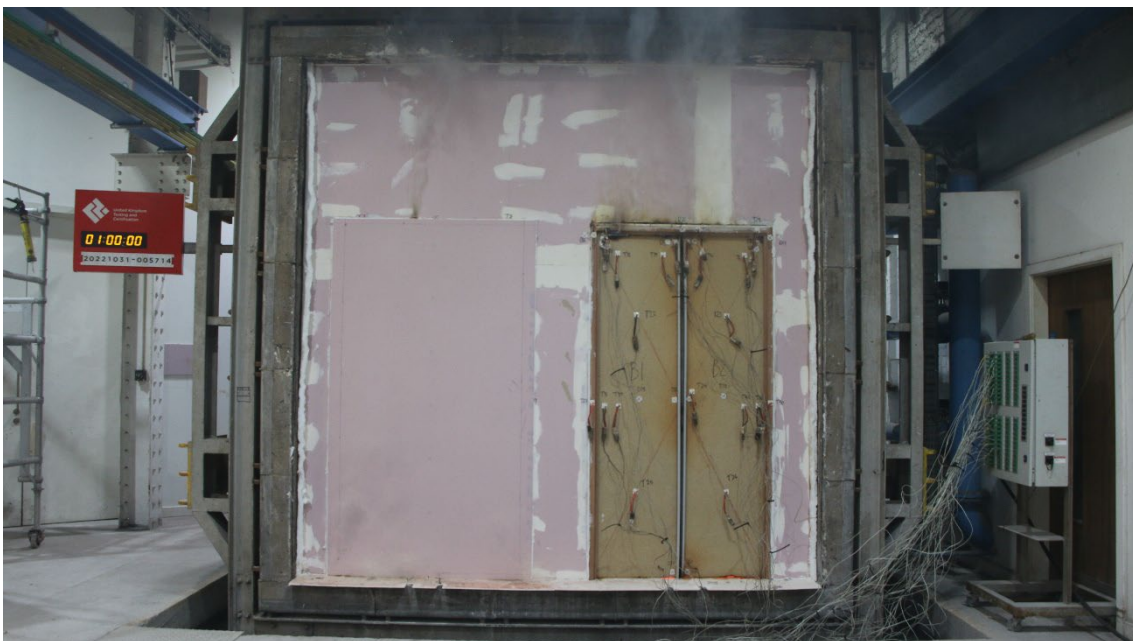
Figure 23 - The unexposed surface of the test construction after a test duration of 60 minutes

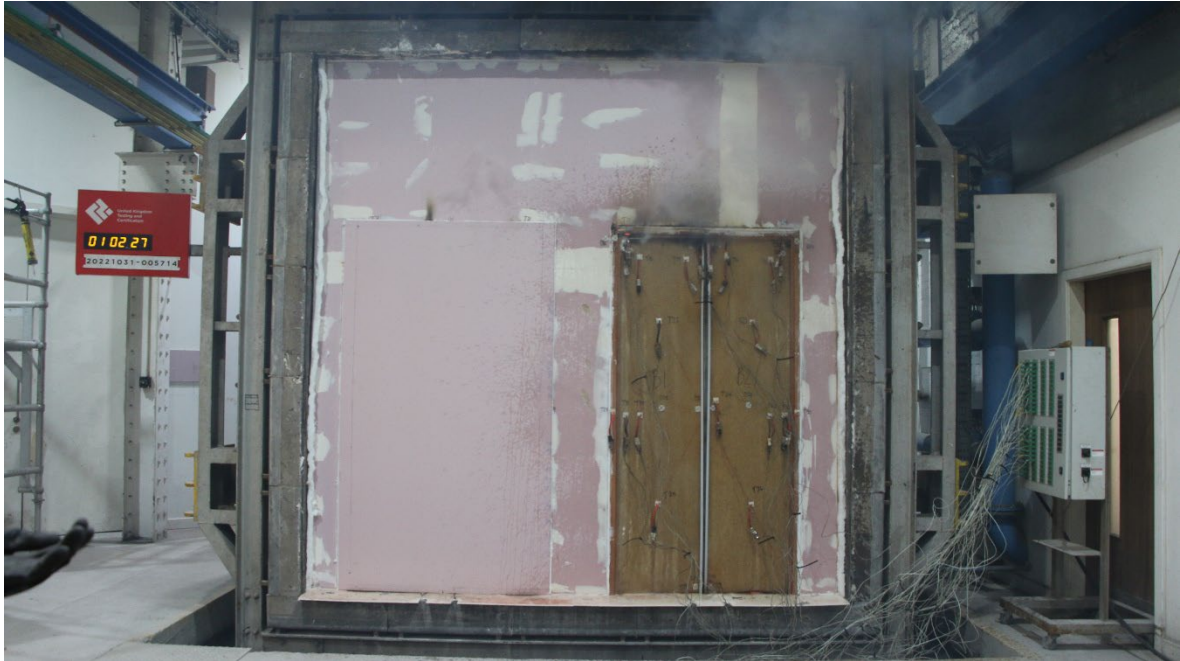
Figure 24 - The unexposed surface of the test construction after a test duration of 62 minutes

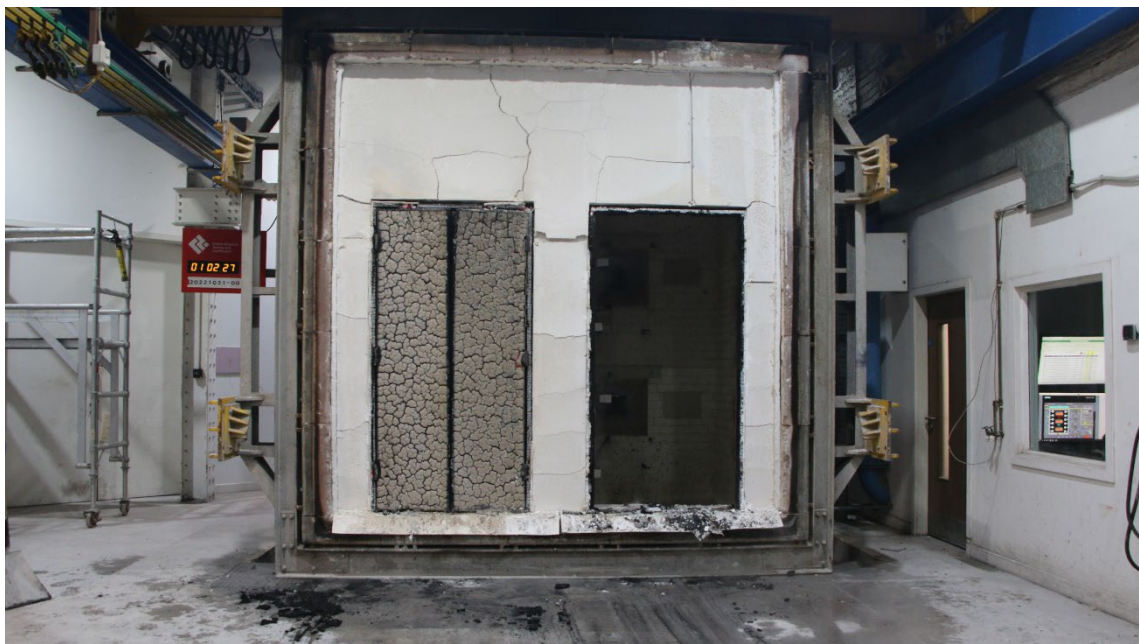
Figure 25 - The exposed surface of the test construction after the test was discontinued

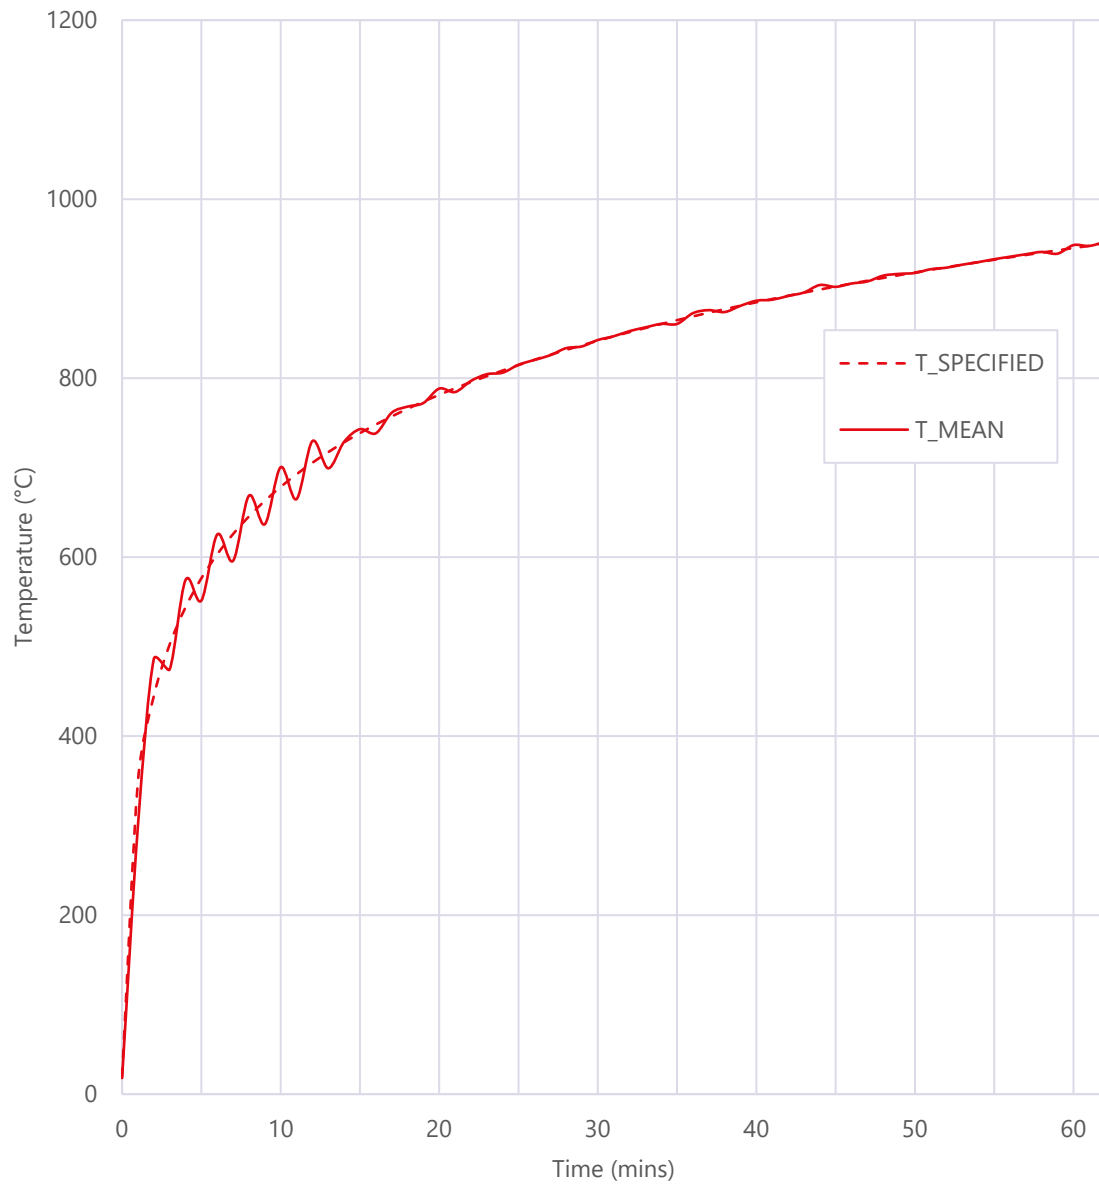
Figure 26 – Graph presenting the Time-Temperature distribution of the furnace

The specimens were subject to heating conditions in accordance with BS EN 1363-1:2020 § 5.1. This was monitored and controlled for the duration of the test using type K thermocouples which were distributed across a vertical plane  $100 \pm 50$  mm from the exposed surface of the test construction. The resulting Time-Temperature distribution is presented in Figure 26.

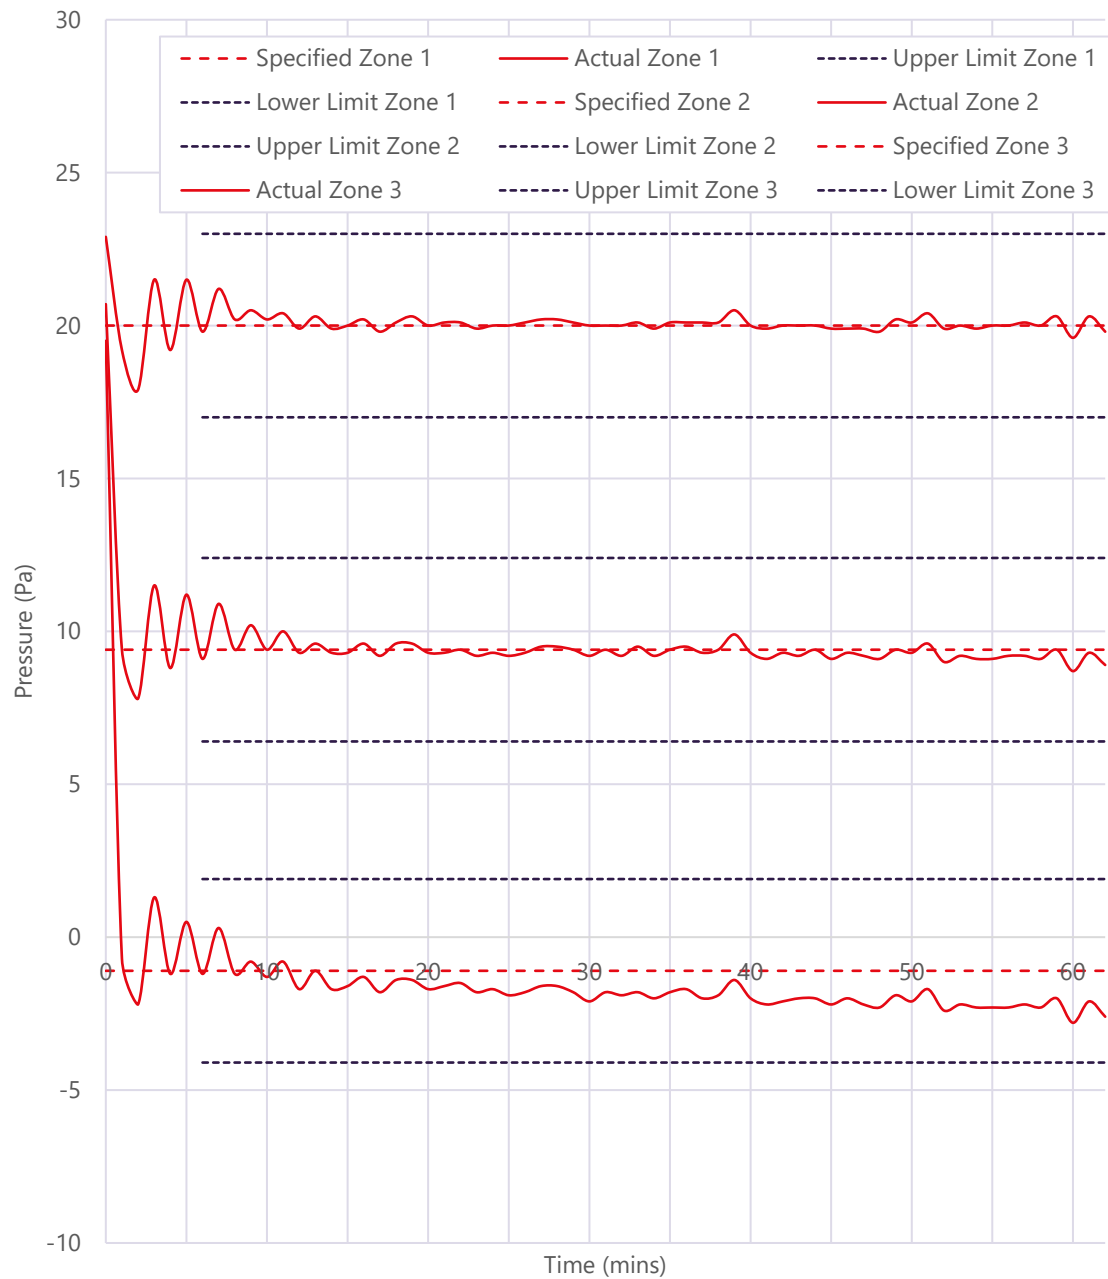
Figure 27 – Graph presenting the Time-Pressure distribution of the furnace

The specimens were subject to a pressure regime in accordance with BS EN 1363-1:2020 § 5.2. The calculated pressure differential relative to the laboratory atmospheric pressure at a height of 365, 1612 and 2850 mm from the furnace floor level was -1.1, 9.4 and 20.0 Pa respectively which equates to 0 Pa at a height of 500 mm from the furnace floor level. The furnace was maintained at these pressures within  $\pm 5$  Pa five minutes after the commencement of the test and  $\pm 3$  Pa ten minutes after the commencement of the test and for the remainder of the test duration. The Time-Pressure distribution is presented in Figure 27.
