# Test Report

The fire resistance performance of two fully insulated, timber, single acting single door assemblies when tested in accordance with BS EN 1634-1:2014+A1:2018

Project ID 20221031-005714

Prepared For RAM Extrusion  
Unit 203  
Stonebridge Cross Business Park  
Pionton Way  
Droitwich Spa  
WR9 0LW

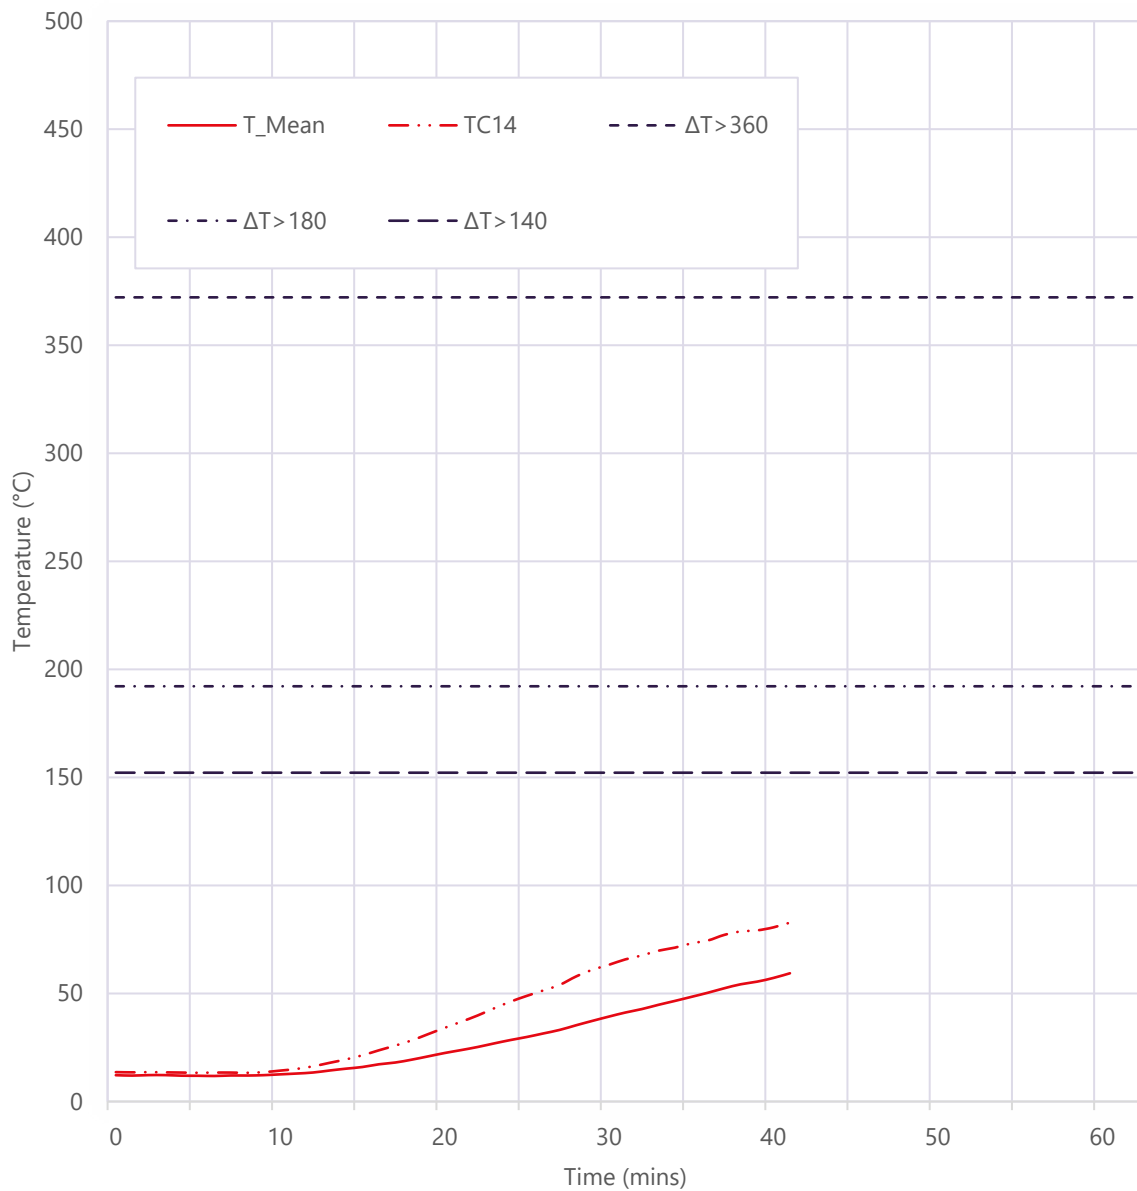
Figure 28 - Graph presenting the Time-Temperature distribution of the unexposed surface of Specimen A

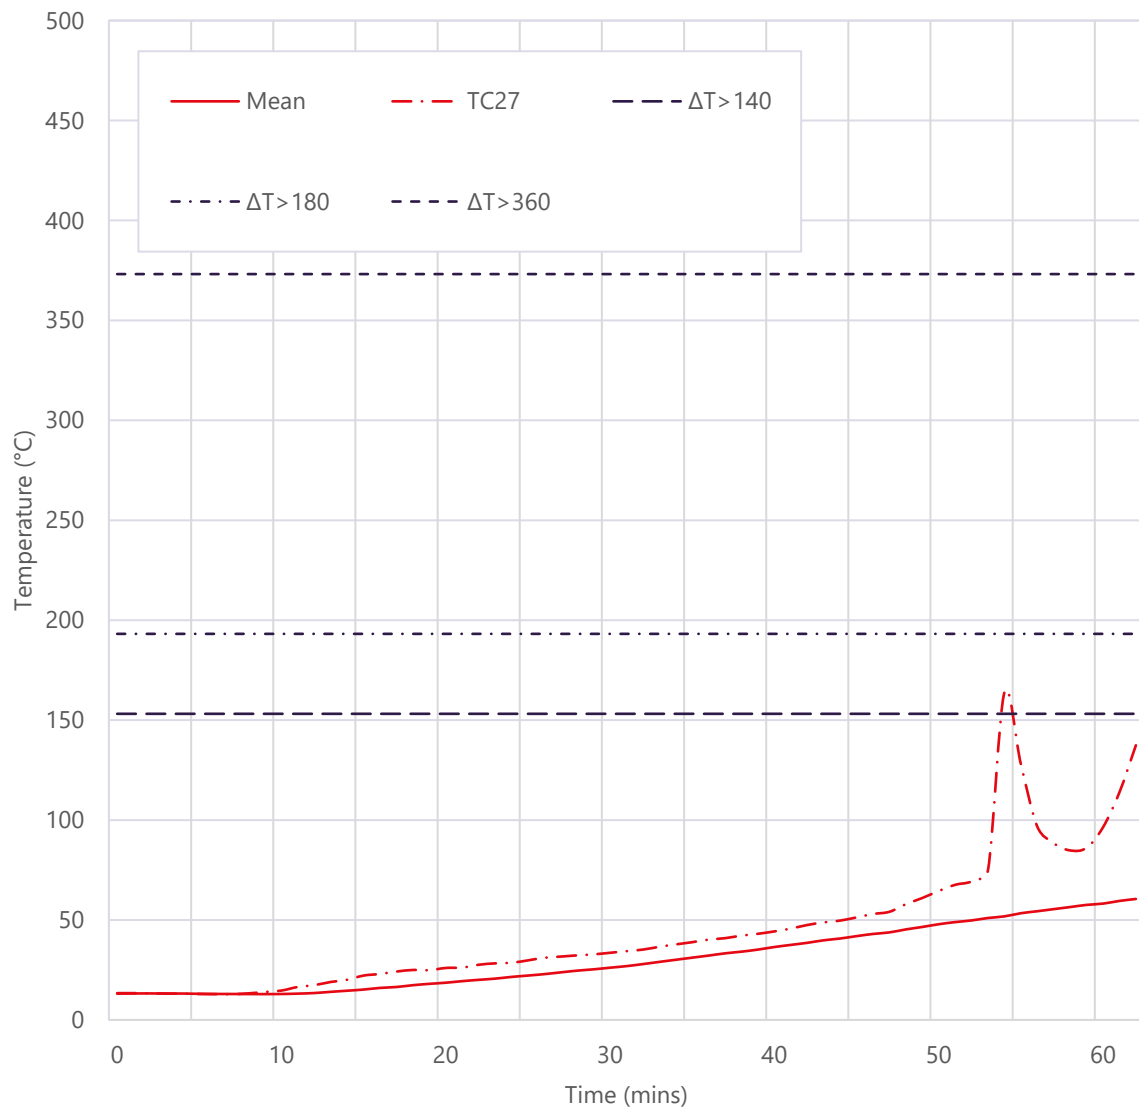
Figure 29 - Graph presenting the Time-Temperature distribution of the unexposed surface of Specimen B
